Ilwaco Marina Conceptual Engineering Report

Client	Port of Ilwaco	
Project name	Port of Ilwaco Marina Repairs Concept Design	
Document title	Ilwaco Marina Conceptual Engineering Design Report	
Document subtitle –		
Status	Final	
Date	June 7, 2021	
Project number	11172	
File reference	Final Ilwaco Concept_Engr_Rpt

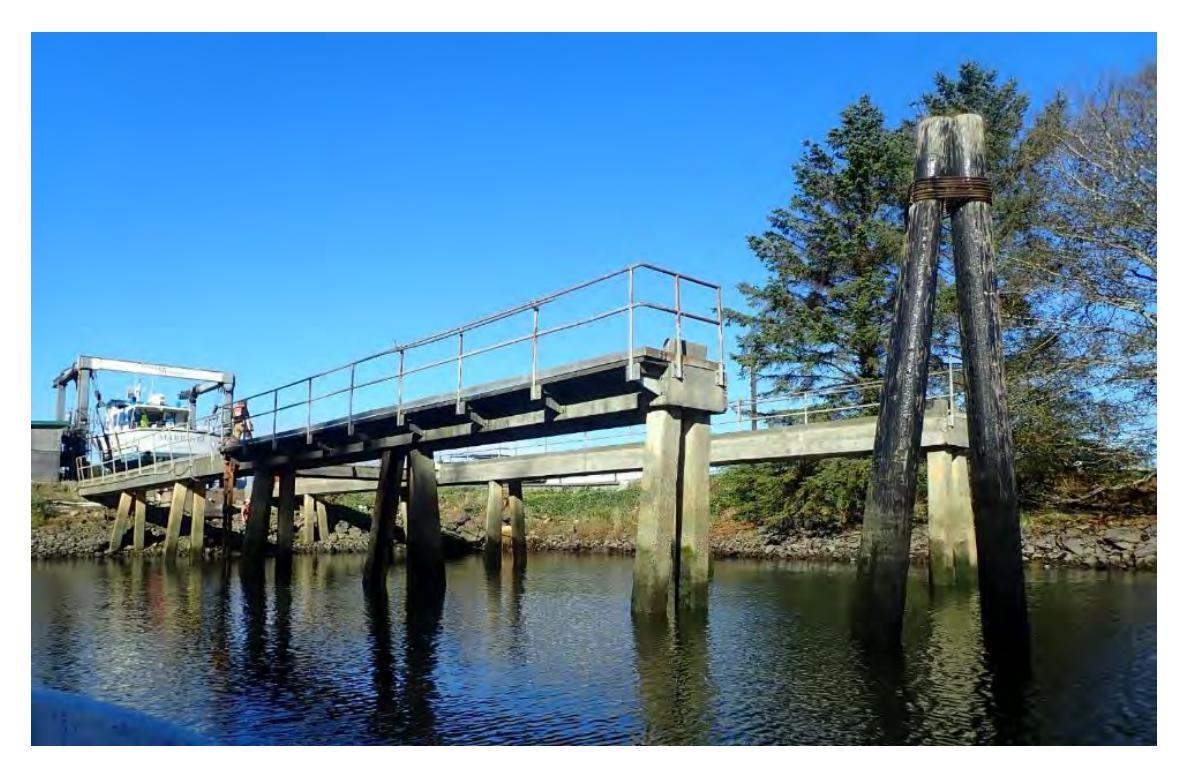
FIGURE 2.3: TRAVELIFT PIER

The TraveLift Pier condition is rated as "*Fair*". All primary structural elements are sound; but minor to moderate defects and deterioration were observed. Localized areas of moderate deterioration are present on the concrete apron structure, but do not significantly reduce its structural capacity. The localized deterioration on the apron structure does not currently affect the structural capacity of the TraveLift Pier itself.

The following repairs are recommended to maintain the facility:

Replacement of the existing TraveLift Pier is discussed in the design section of this report as an alternative that would increase the capacity of the structure to accommodate the larger lift equipment recently purchased by the Port.

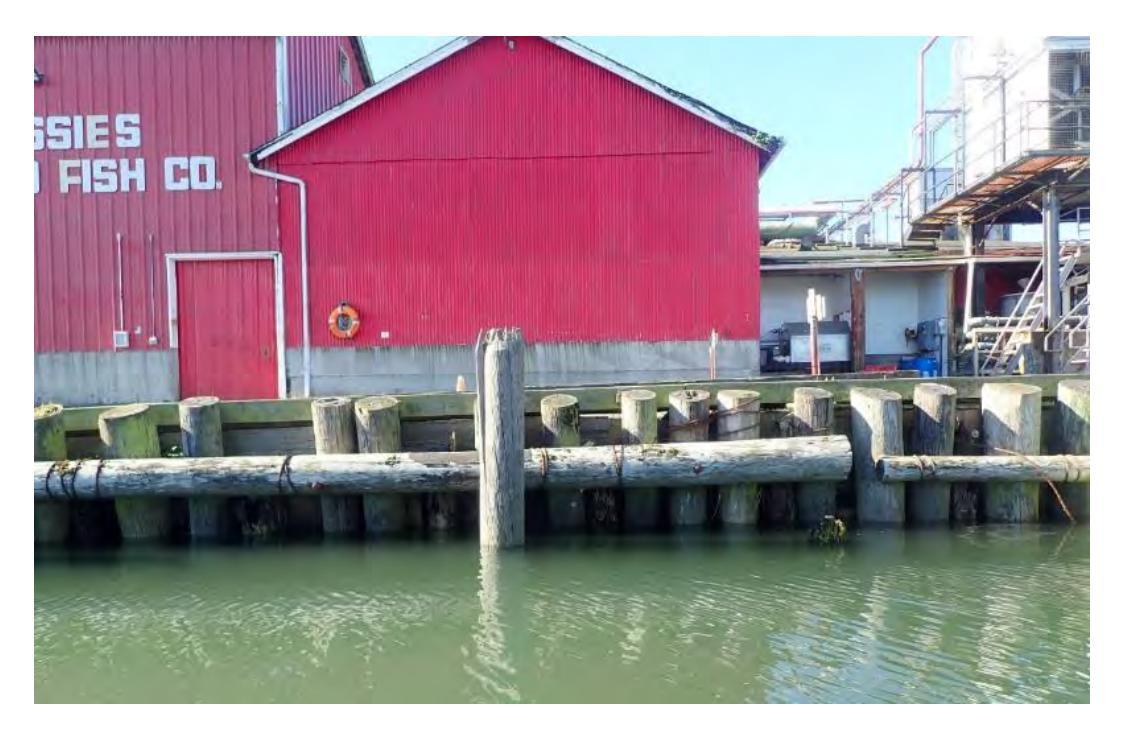
FIGURE 2.5: EAST BULKHEAD

The East Bulkhead is rated as "Serious". Advanced deterioration and breakage have affected the load-bearing capacity of the bulkhead. The bulkhead experiences overtopping during extreme storm and tidal events. Due to the extent and nature of the deterioration, as well as overtopping of the bulkhead, it is assumed that repairing the structure in-kind is cost prohibitive, therefore, alternatives for replacement of the bulkhead were evaluated.

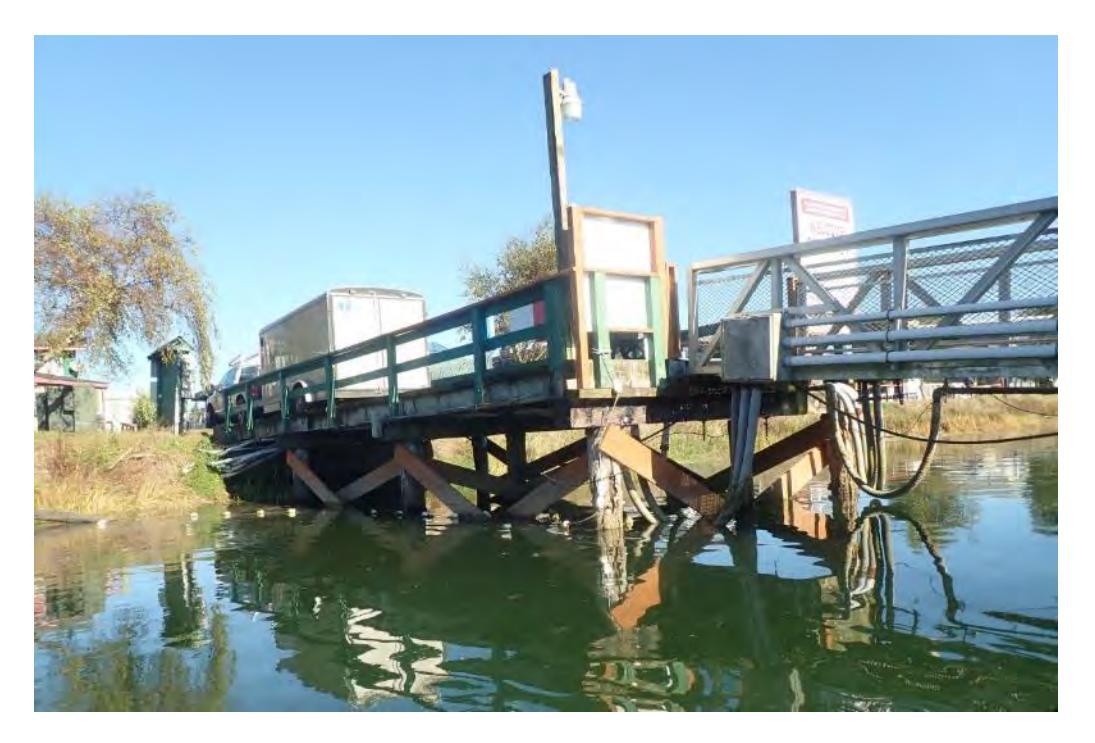
FIGURE 2.7: WEST ACCESS PIER

The West Access Pier is rated as "*Serious*". Advanced deterioration of the timber piling has affected the load-bearing capacity of the pier. Due to the extent and nature of the deterioration, it is assumed that repairing the structure in-kind is cost prohibitive, therefore, alternatives for replacement of the pier should be evaluated. If full replacement is not the preferred alternative, the following repairs are recommended:

- Install structural pile jackets on all piles (nine total).
- Restore Piles 4:B and Pile 3:C to full bearing, and install steel straps to secure the piles to the pile cap.
- Repair broken electrical fittings.
- Replace cracked water flex hose.

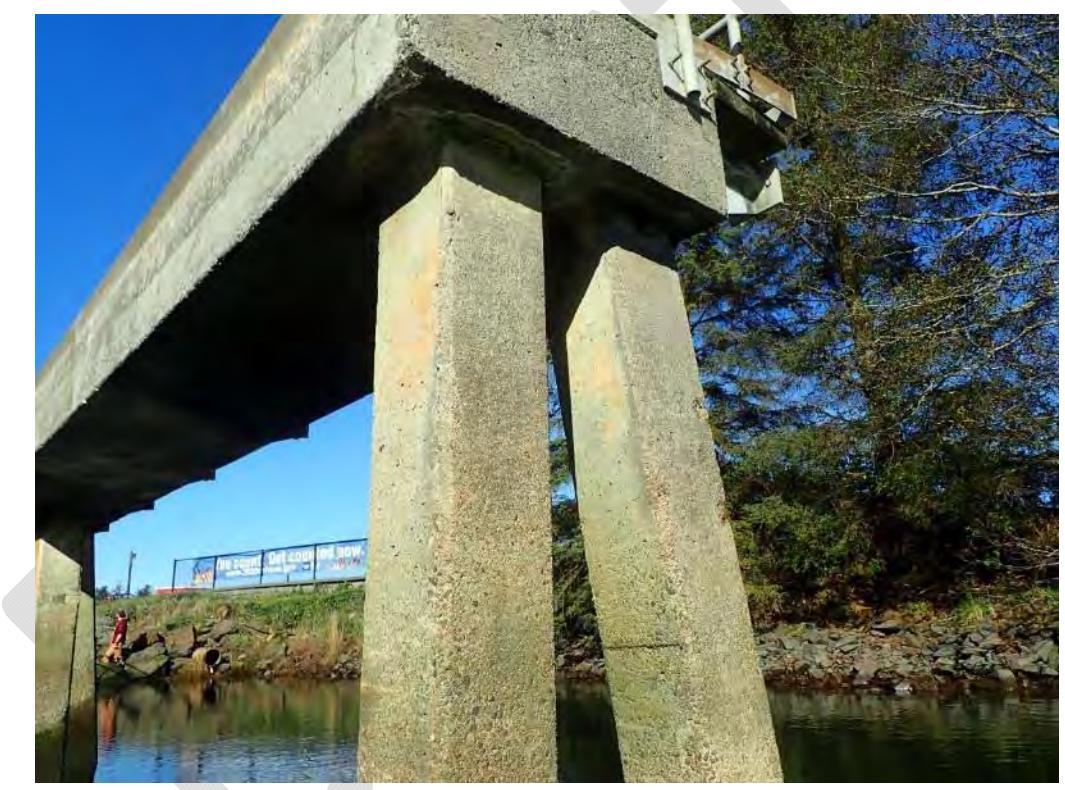
Photograph 2: Typical Concrete Piles

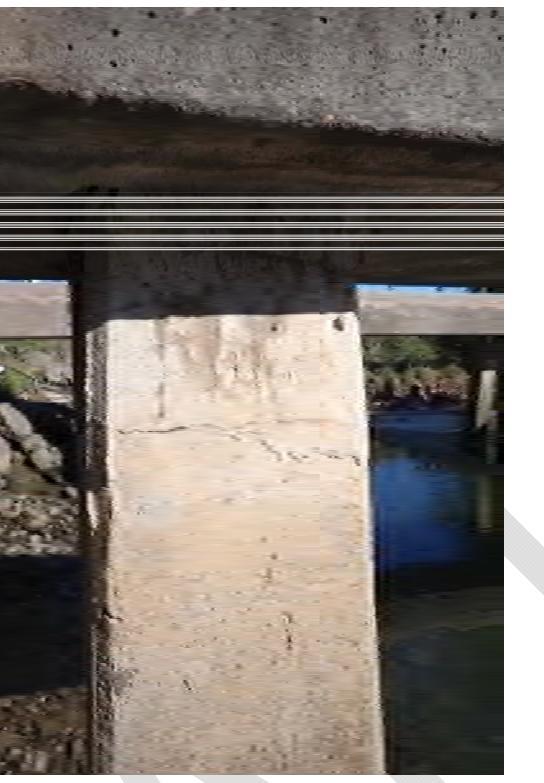
Photograph 3: Moderate Cracking on Pile 2:A

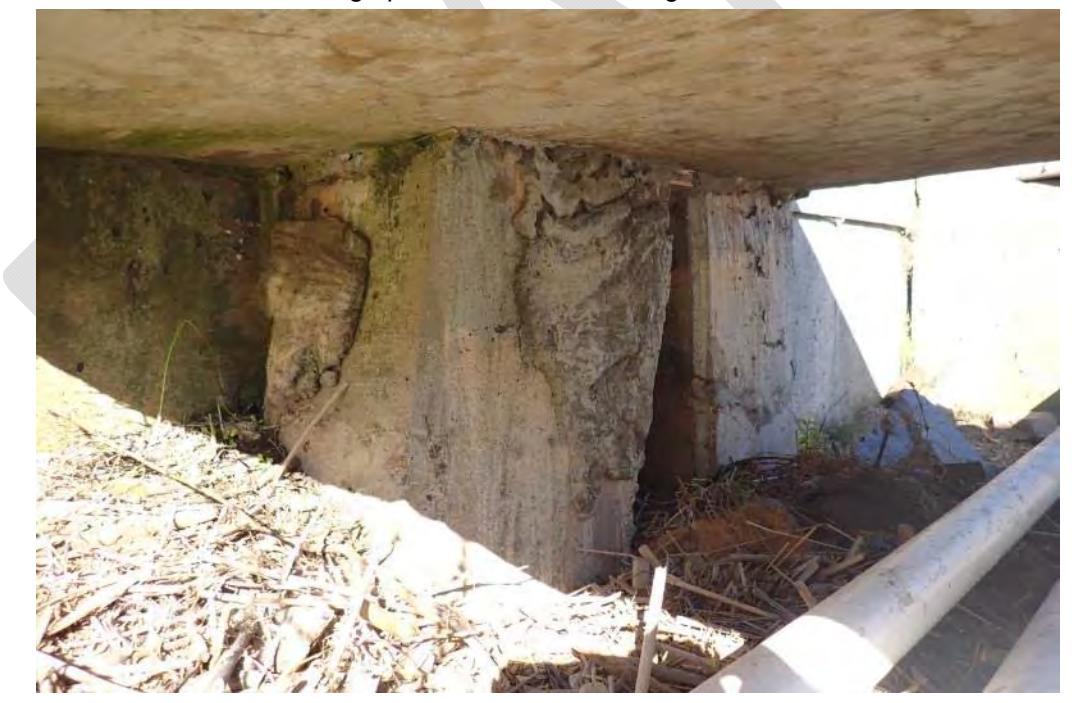
Photograph 4: Corner Spall Repair on Pile 1:A

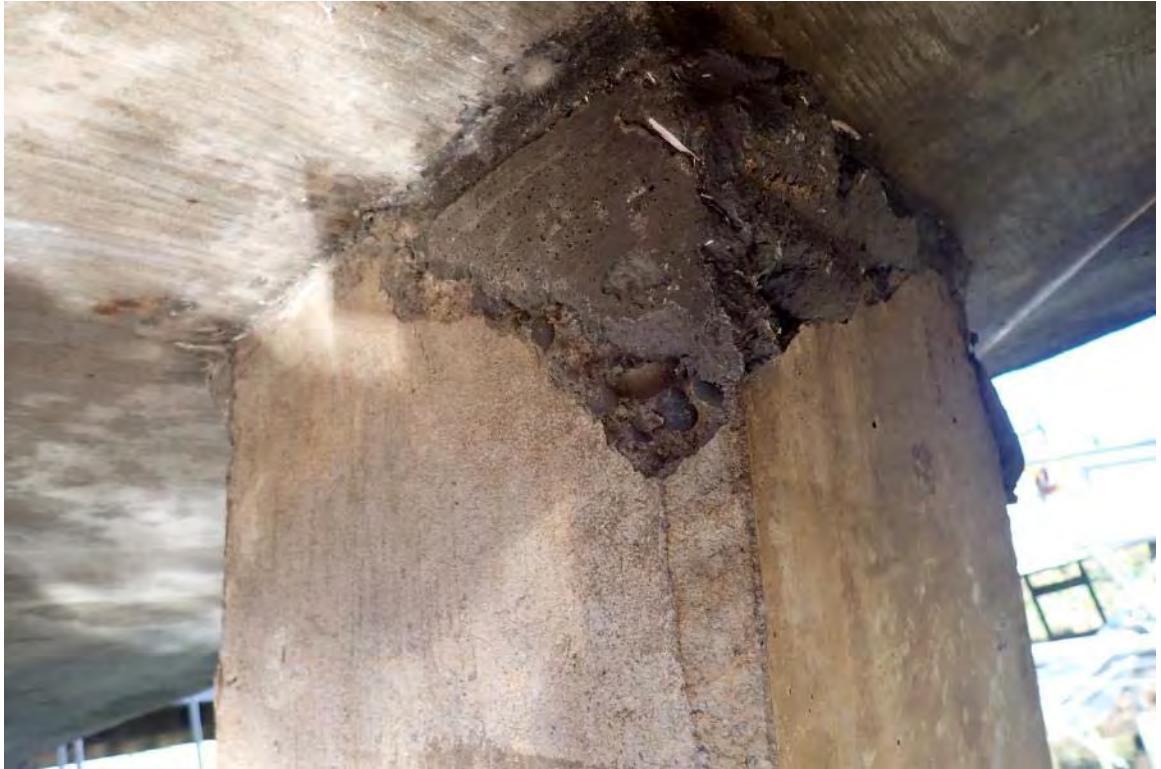
Photograph 5: Corner Spall Repair on Pile 2:A

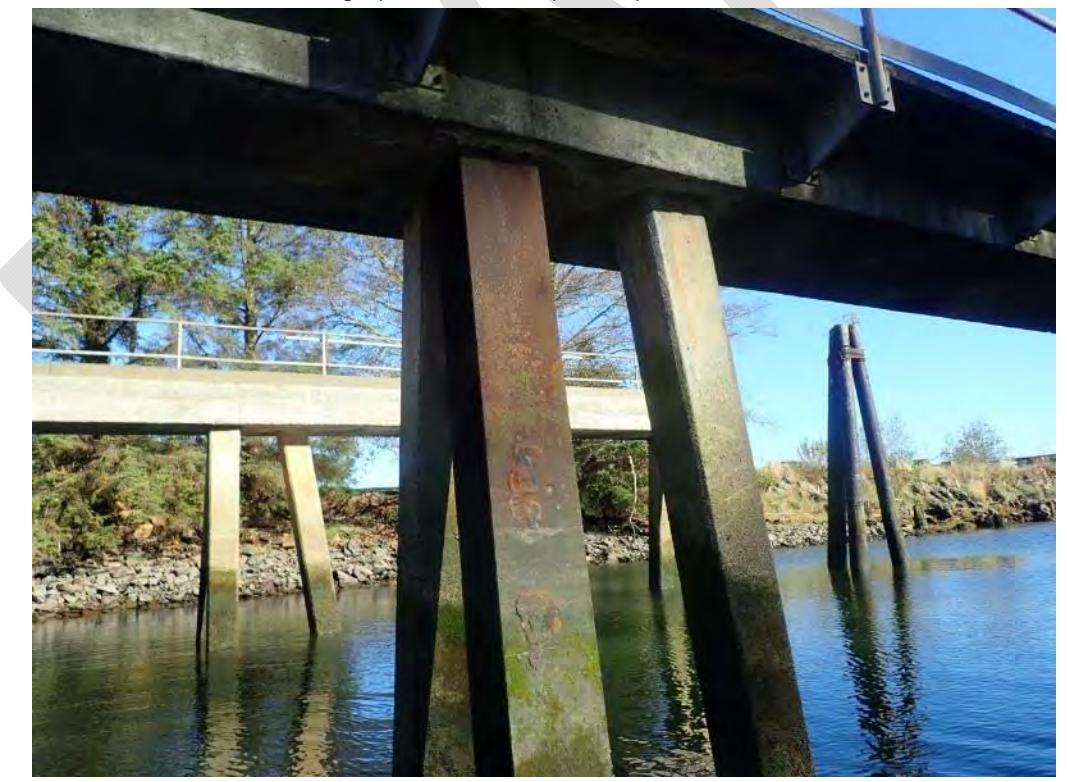
The steel H-Pile exhibits moderate corrosion over the entire surface area above water. The corrosion does not appear to have resulted in measurable section loss. Photograph 6 shows the steel H-Pile.

Photograph 6: Steel H-Pile at Bent 5:A

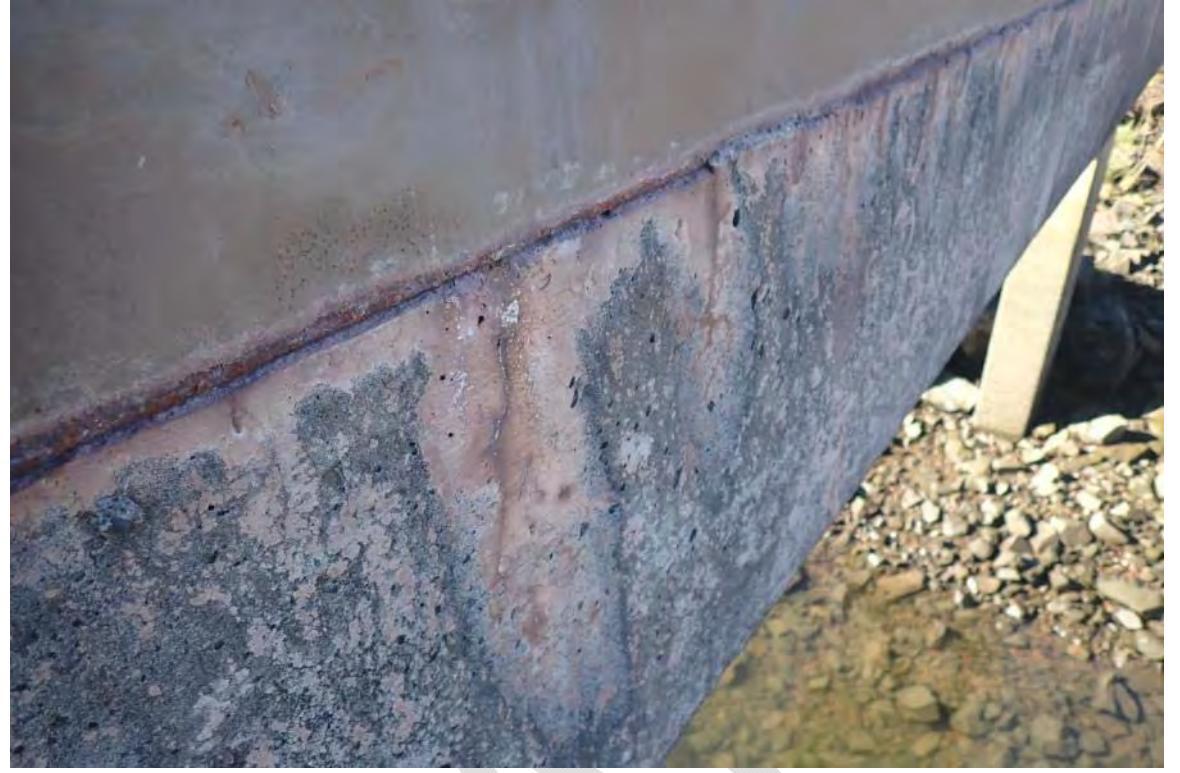
Minor vertical hairline cracks measuring one-inch to nine-inches long are present along the full length of the beams. These hairline cracks are along the connection interface between the beam and the wheel guide/kick plate. Photograph 8 and Photograph 9 show typical examples of the hairline cracks.

Photograph 8: Typical Cracking Beneath Wheel Guide/Kick Plate

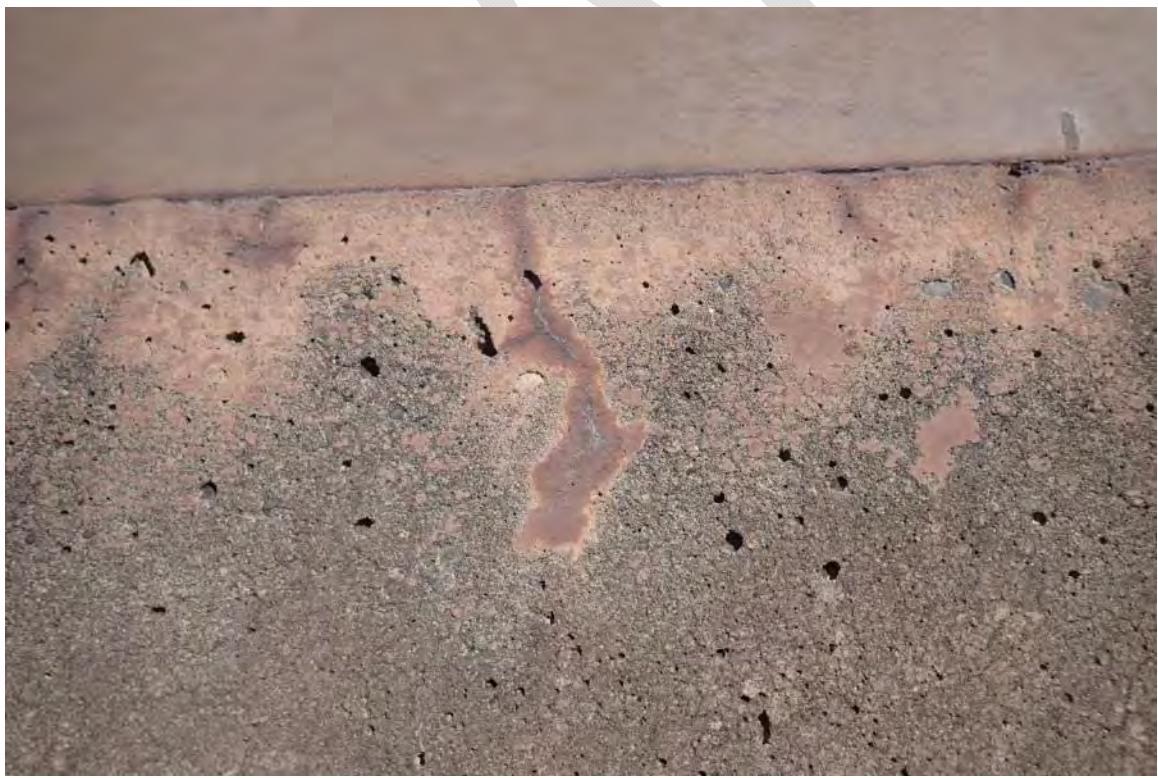
Photograph 9: Typical Cracking and Rust Staining

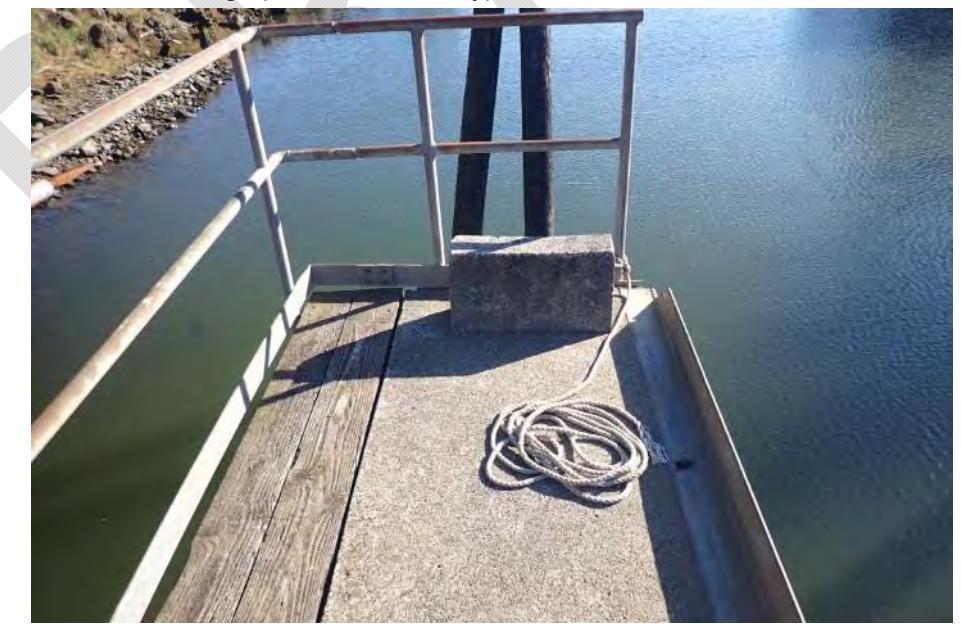
Galvanized steel handrails are located along the outer perimeter of the runway beams. The handrails consist of steel posts at six-foot spacing with top rails, mid rails, and toe plates. The handrail posts are attached to the runway beams with base plates and anchor bolts. Minor corrosion is present on isolated portions of the handrail. Photograph 10 shows the typical condition of the handrails.

Photograph 10: Typical Handrail with Minor Corrosion

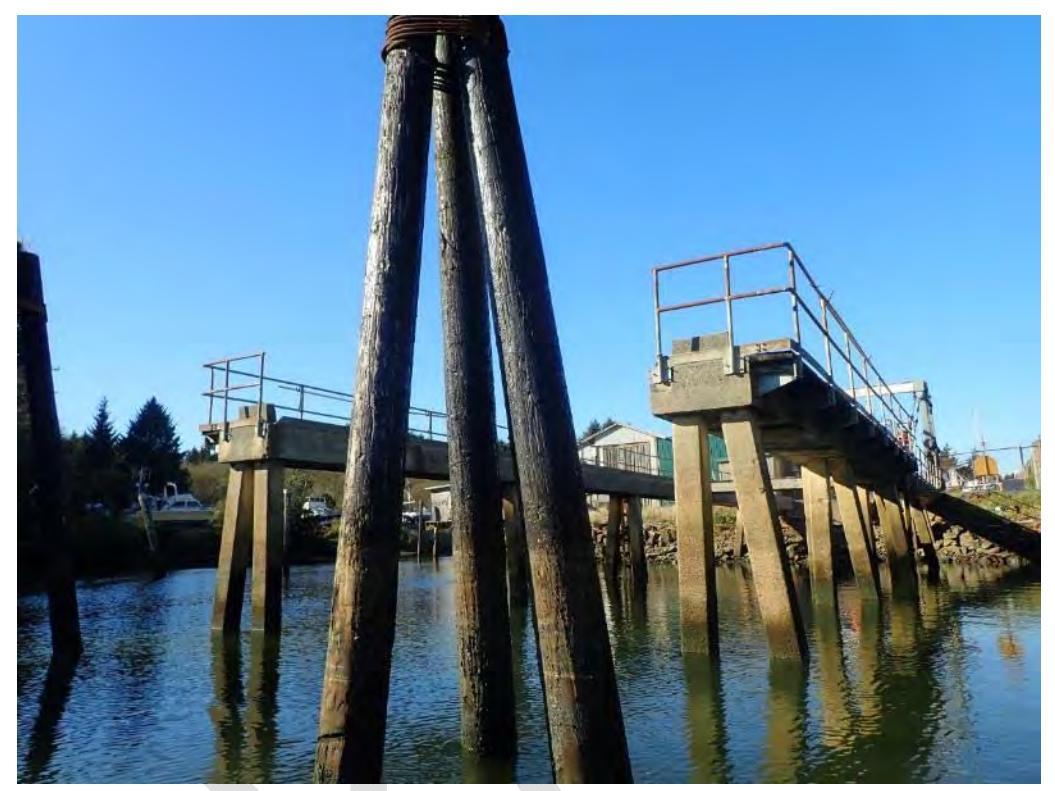
Two timber dolphins, each consisting of three creosote-treated batter piles, are located at the southern end of each runway. Minor damage, including checking and splitting is present. The east timber dolphin is shown Photograph 12.

Photograph 12: Typical Timber Pile Dolphin

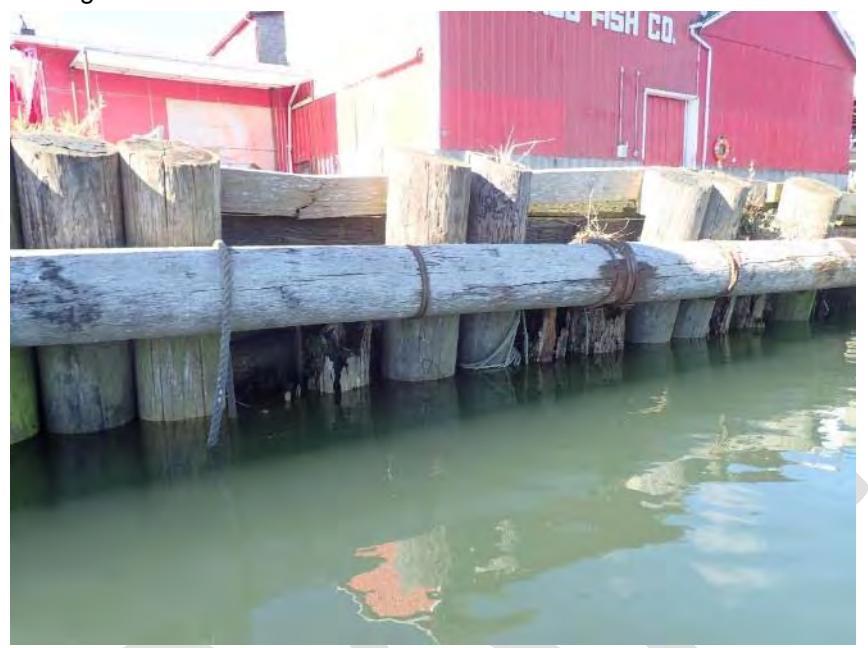
Minor damage, including checking and splitting less than ½-inch wide is present on all of the East Bulkhead timber piling. Moderate to major rot is present in the upper 12-inches of 26 of the 118 timber piling (22-percent). Severe damage and deterioration, including section loss greater than 50-percent and missing or broken piling is present on 18 of the 118 timber piling (15-percent). Photograph 17 shows several of the piles with severe damage.

Photograph 17: East Bulkhead Piles

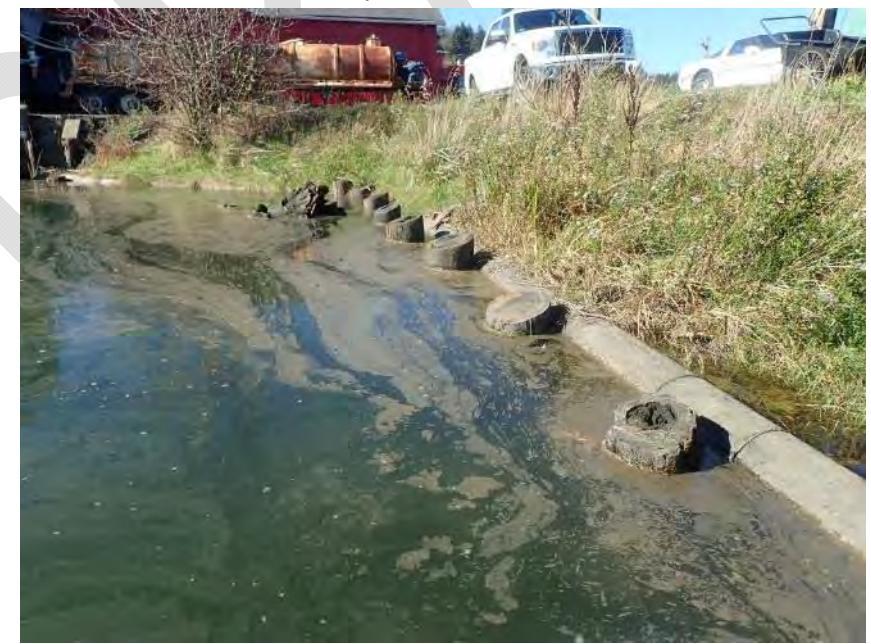
Minor damage, including checking and splitting less than ½-inch wide is present on all of the North Bulkhead timber piling that were visible at the time of inspection. The northern bulkhead is shown in Photograph 18.

Photograph 18: North Bulkhead Piles (Water Level Approx. +6.3-feet MLLW)

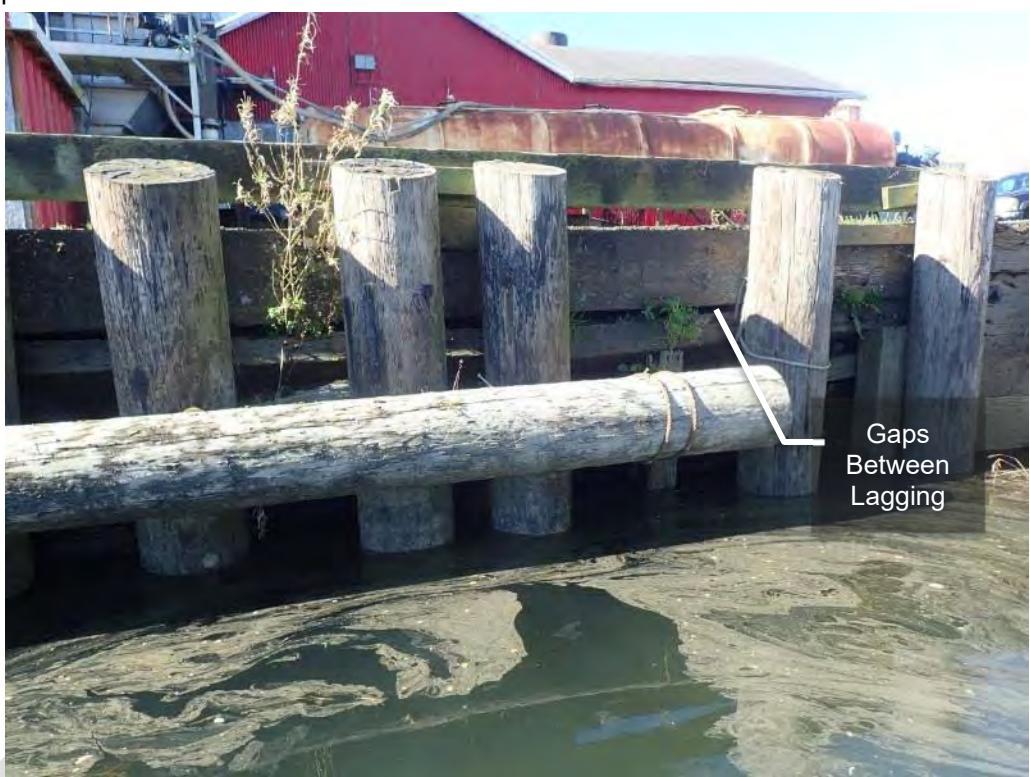
Minor damage, including checking and splitting is present throughout the lagging and waler members. Additionally, moderate to severe deterioration of the lagging, including section loss, and breakage is present. The deterioration has led to gaps between adjacent lagging members, measuring up to several inches wide and allows for loss of backfill material. This loss of material has led to subsidence of the upland area. The East Bulkhead lagging, walers, and tieback strands are shown in Photograph 19 through Photograph 21.

Photograph 19: East Bulkhead Lagging

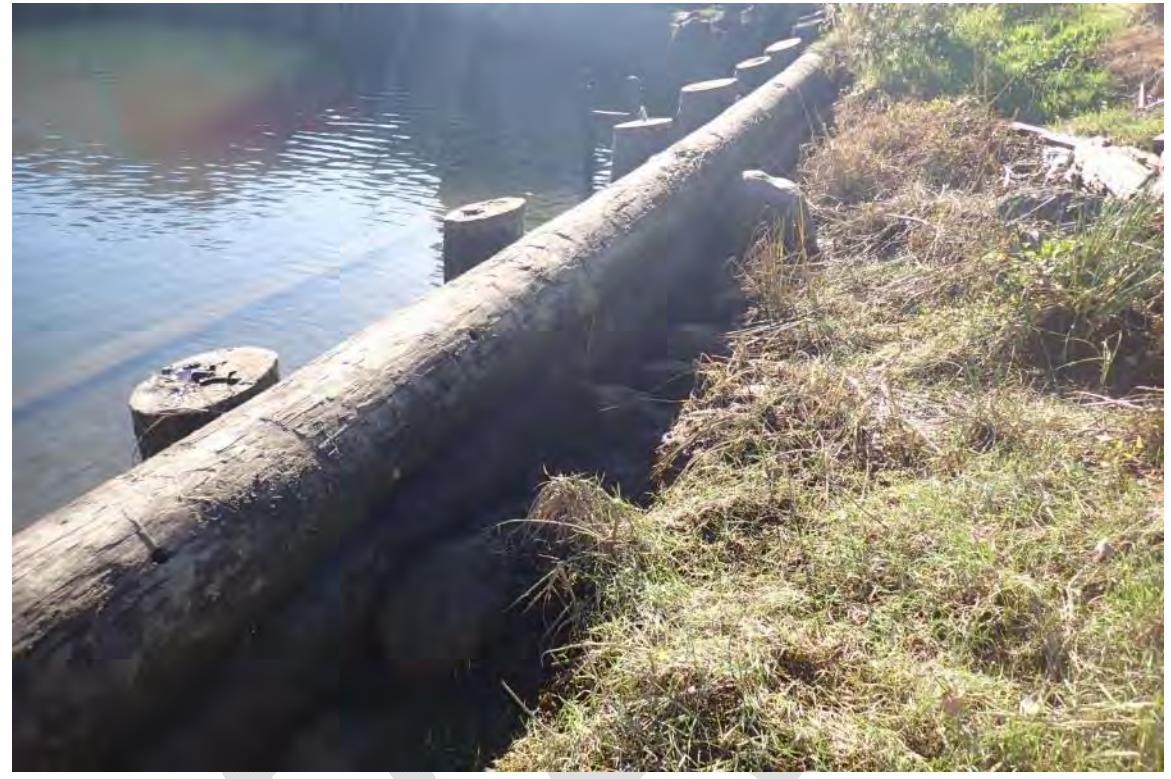
The North Bulkhead lagging consists of timber piles laid horizontally behind the vertical bulkhead piles. The lagging measures approximately 14-inches in diameter. Minor damage, including checking and splitting is present. The north bulkhead lagging is shown in Photograph 22.

Photograph 22: North Bulkhead Lagging

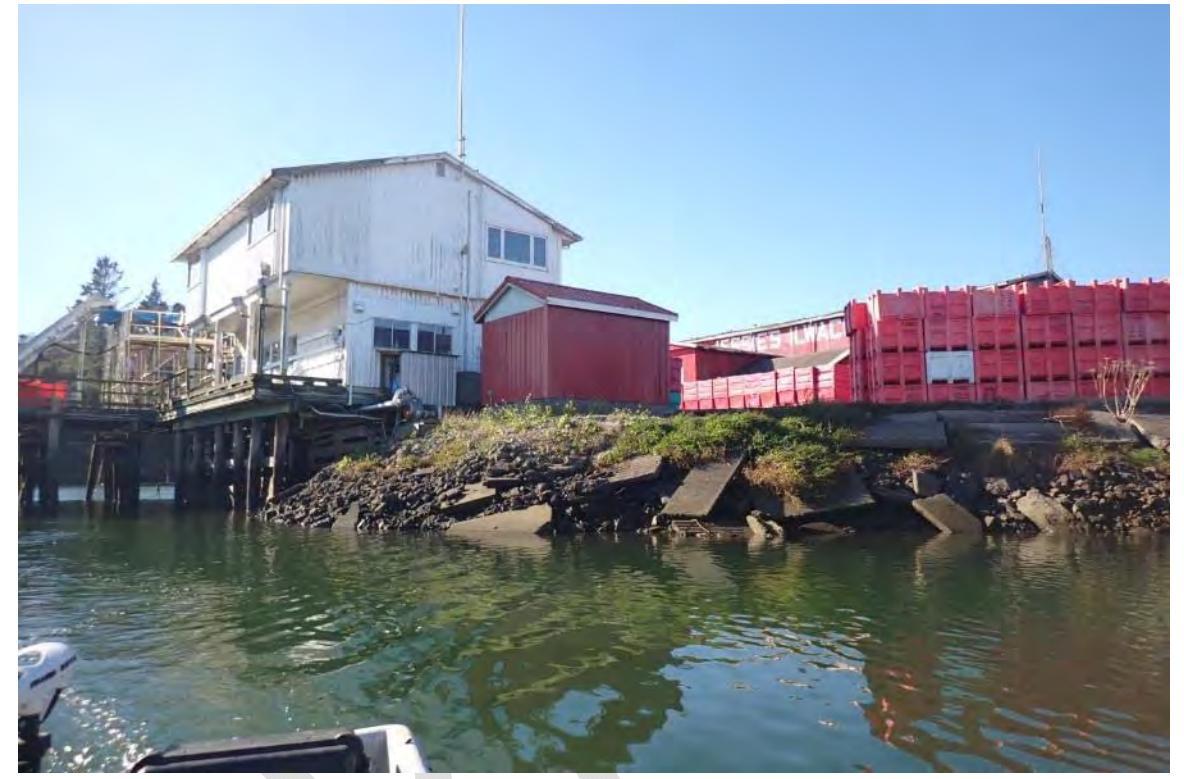
The shoreline immediately south of the East Bulkhead consists of mix-sized riprap, broken concrete debris and sparse vegetation. No evidence of advanced erosion of sloughing is present, however, the inconsistency of riprap size suggests that some material may have moved or been displaced since the original construction of the shoreline. Photograph 23 shows the typical condition of the south shoreline.

Photograph 23: East Bulkhead South Shoreline

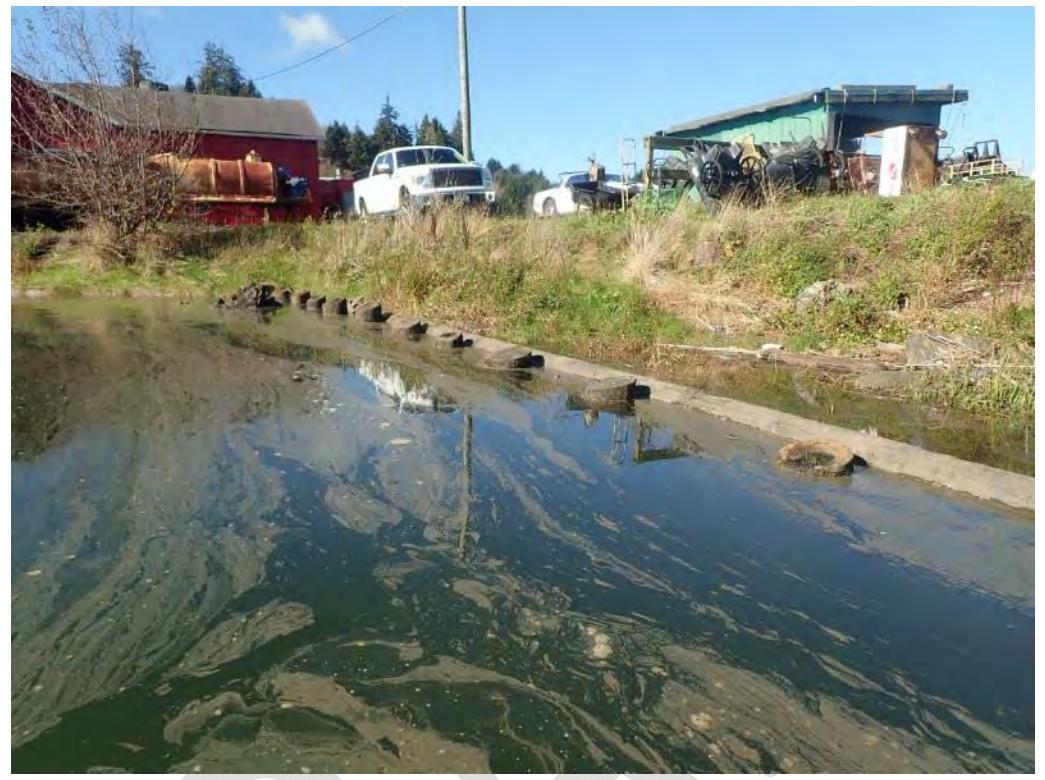
The shoreline northeast of the East Bulkhead and adjacent to the North Bulkhead consists of a vegetated slope and timber debris. No evidence of advanced erosion of sloughing is present. Photograph 24 show the typical condition of the north shoreline.

Photograph 24: North Bulkhead Shoreline, Looking Northwest

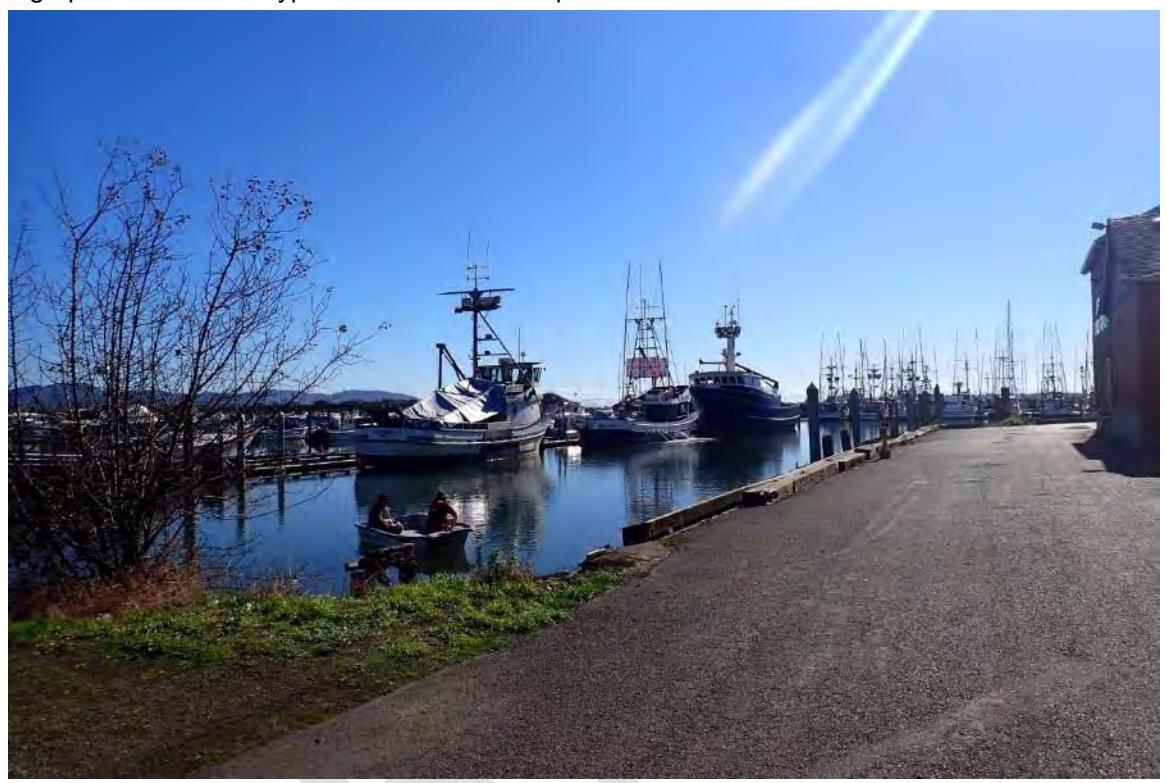
The upland area of the East Bulkhead consists of a paved driving surface used for accessing portions of the Jessie's Fish Co. building. The pavement is generally free of damage or significant deterioration, however, the pavement appears to have localized areas of subsidence adjacent to the bulkhead. Photograph 25 shows the typical condition of the upland area.

Photograph 25: East Bulkhead Upland

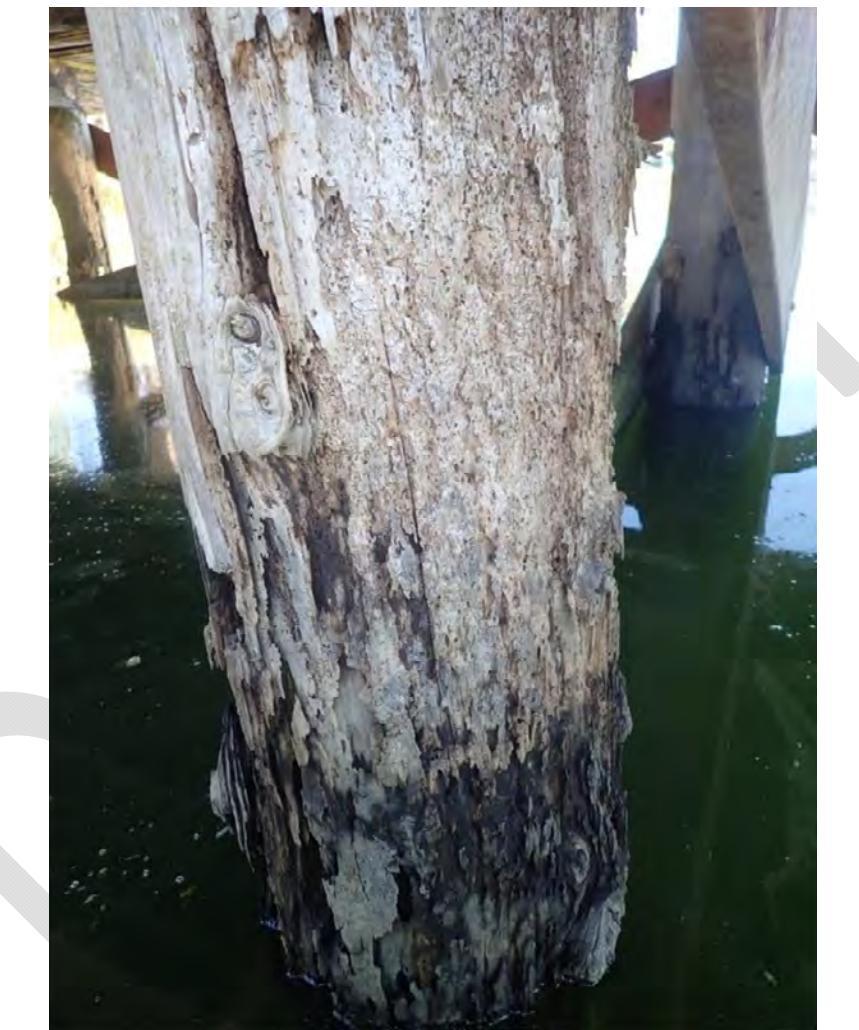
Photograph 27: West Access Pier Typical Timber Pile with Shell Delamination

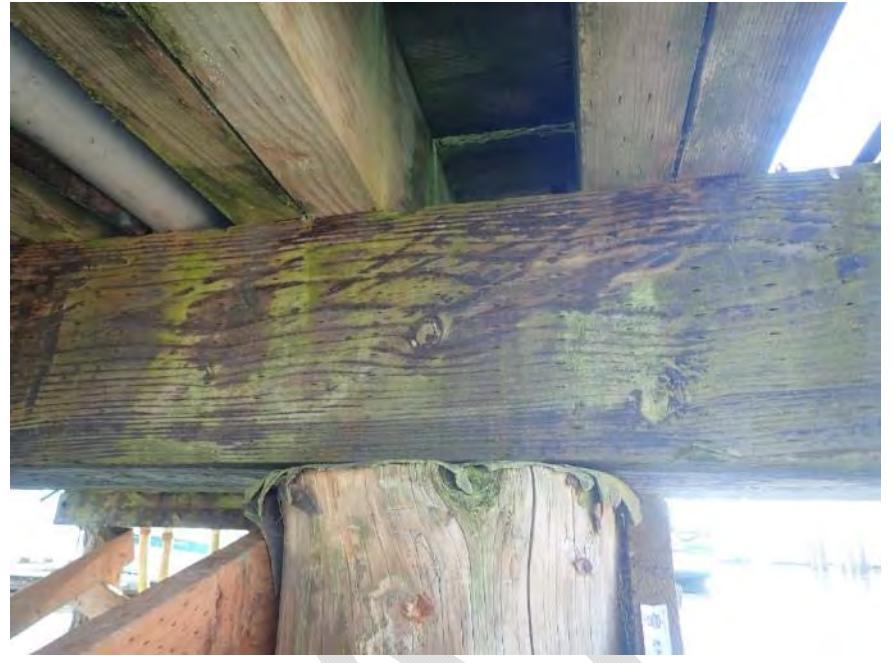
The West Access Pier pile caps are creosote treated 12x12 timber members. Typically, there is no damage or deterioration of the pile caps. Photograph 30 shows a typical pile cap.

Photograph 30: West Access Pier Timber Pile Cap

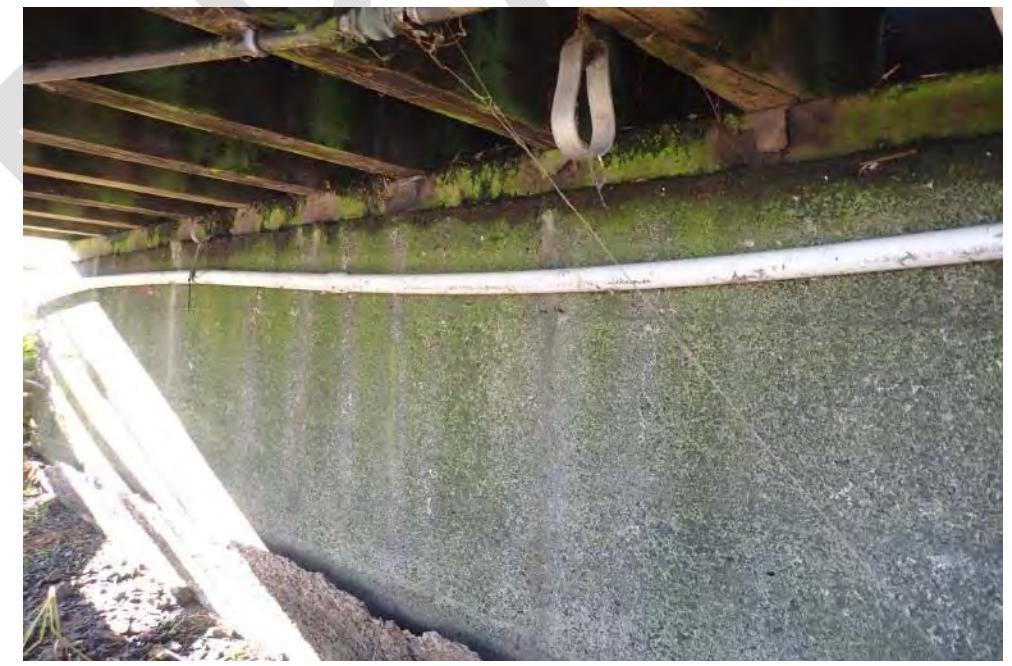
A reinforced concrete abutment provides a transition to the landside area of the West Access Pier. In general, no damage or deterioration was observed on the concrete elements of the abutment, and no signs of localized settlement or erosion are present. Photograph 31 shows the typical condition of the abutment.

Photograph 31: West Access Pier Abutment

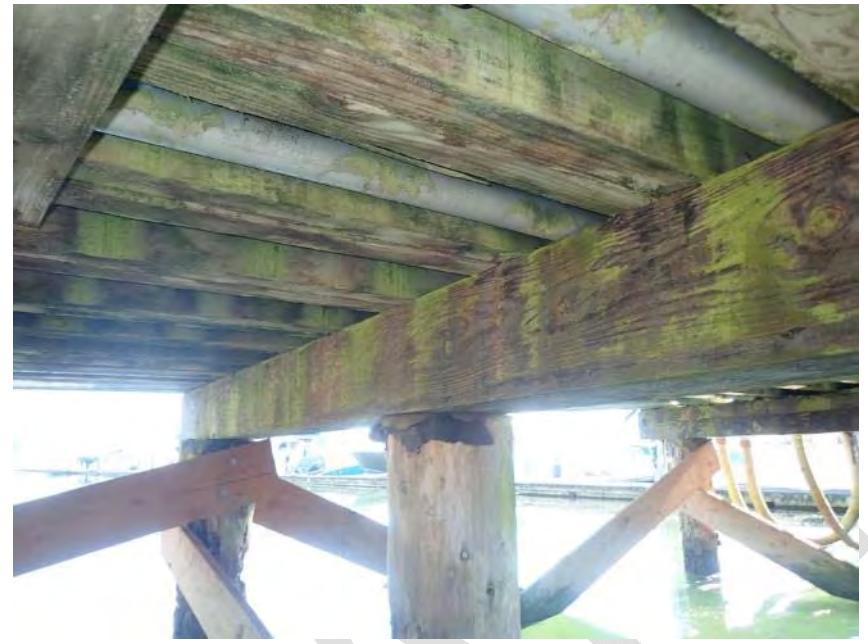
The stringers are pressure treated 4x12 timber members at 16-inch spacing. The stringers are double span, and lapped at the pile caps with toenail connections to the pile cap. The pile caps exhibit no damage or deterioration. Photograph 32 shows the typical condition of the stringers at Bent 3.

Photograph 32: West Access Pier Timber Stringers

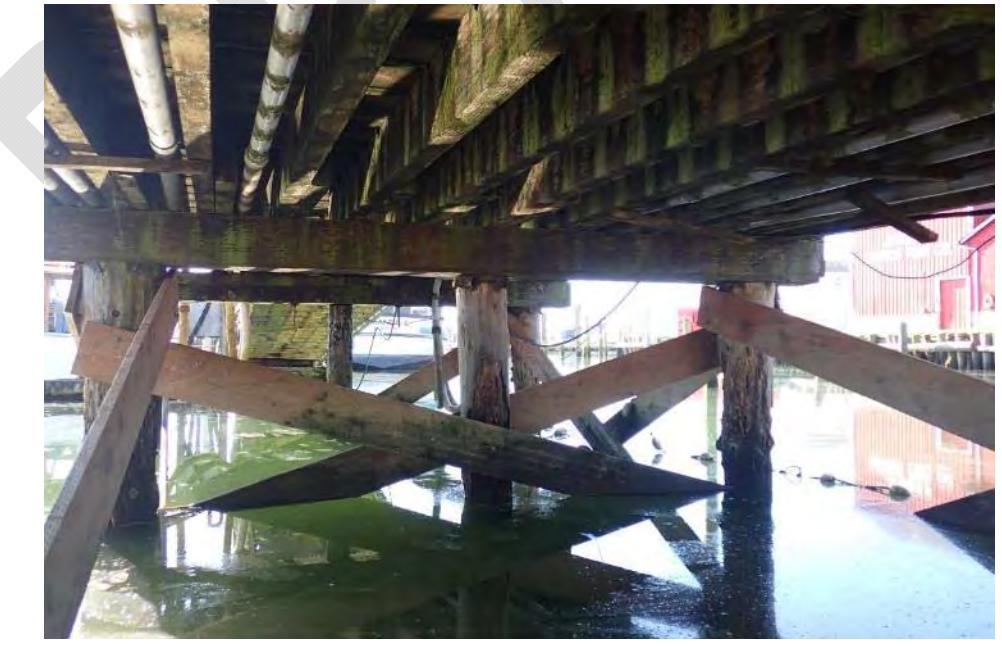
The timber cross bracing for the West Access Pier is pressure treated 2x12 members positioned longitudinally along Row A and Row C and transversely along Bent 3 and Bent 4. The bracing exhibits no damage or deterioration. Photograph 33 shows the typical condition of the cross bracing.

Photograph 33: West Access Pier Timber Cross Bracing

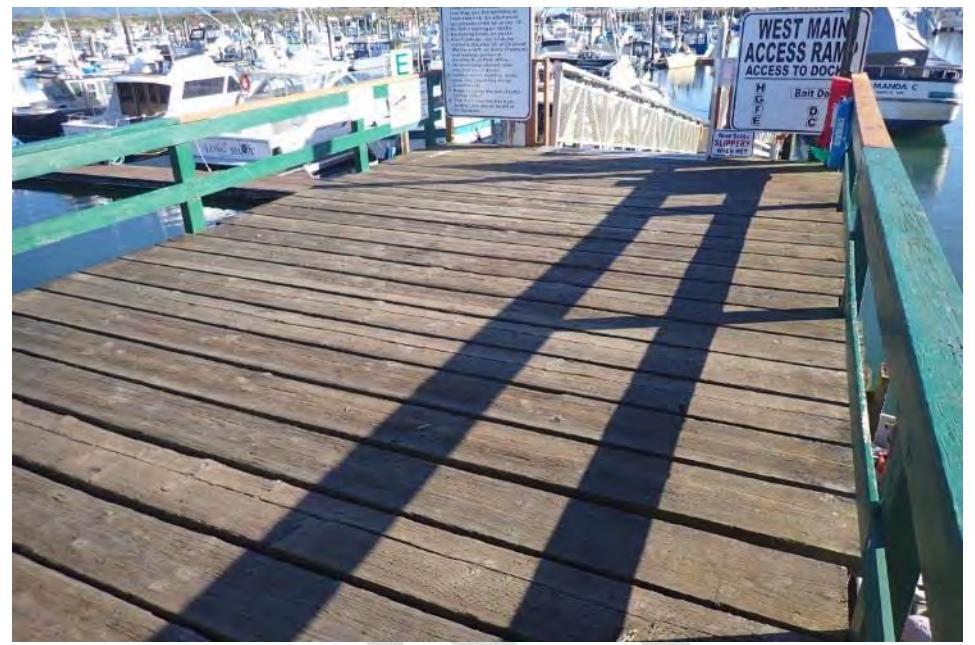
The timber decking for the West Access Pier is comprised of 3x12 timbers oriented 90-degrees to the stringers. The decking typically has no damage or deterioration. Photograph 34 shows the typical condition of the decking.

Photograph 34: West Access Pier Timber Decking

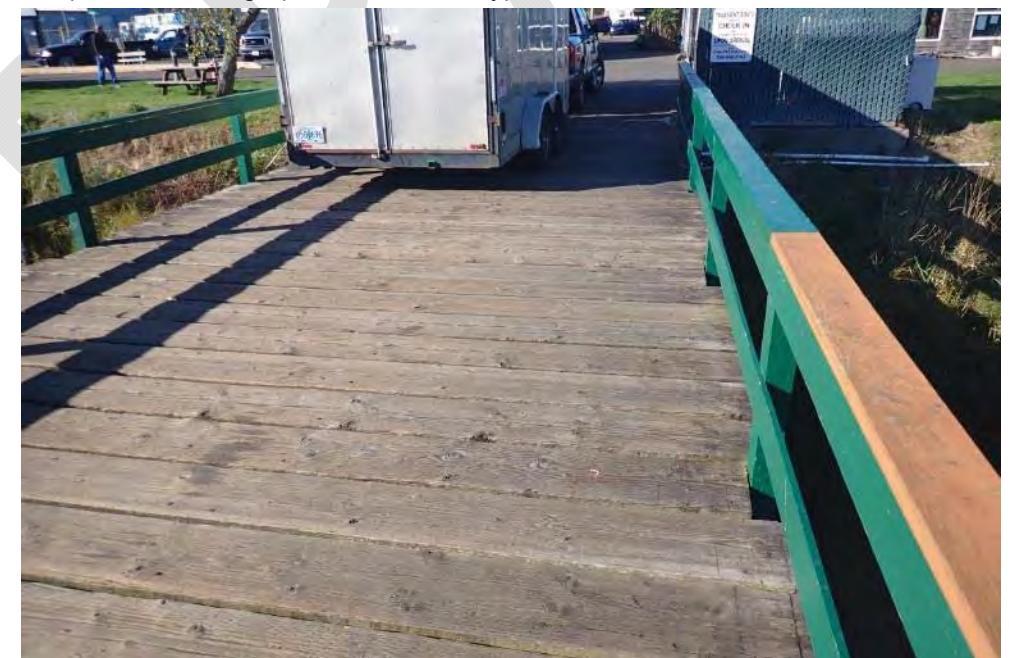
Timber handrails are located along the outer perimeter of the West Access Pier and consist of timber posts, top rails, and mid rails. The handrail posts are attached to the stringers with lag bolts. No damage or deterioration is present. Photograph 35 shows the typical condition of the handrails.

Photograph 35: Typical Handrail

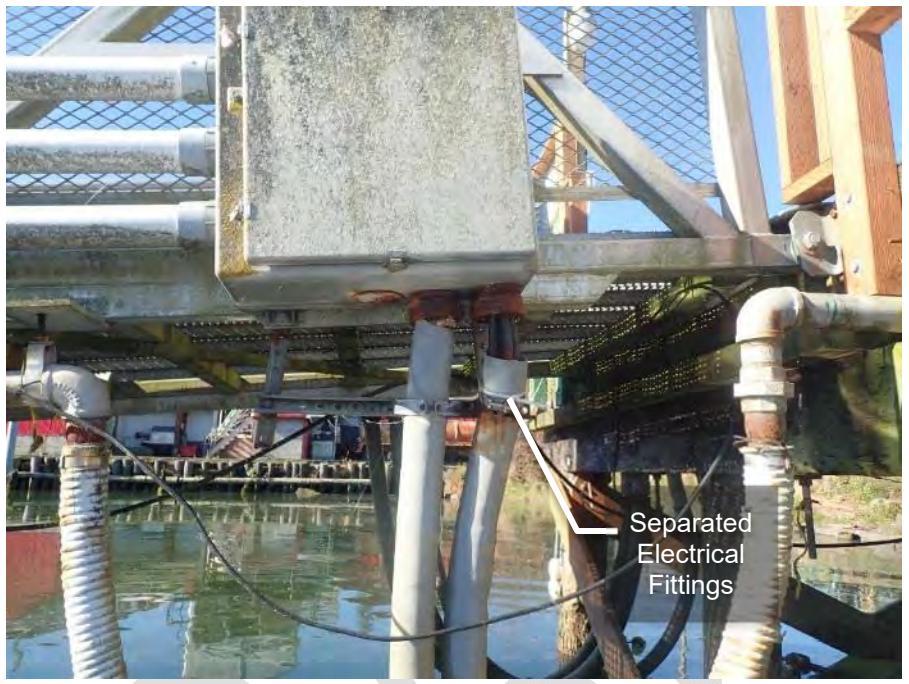
Utility conduit and piping for electrical and water systems are hung from the West Access Pier and transition onto an aluminium gangway. The electrical flex connection on the east side of the gangway has separated from the junction box and the water line flex hose is cracked near the southeast corner of the pier. Photograph 36 and Photograph 37 show the typical condition of the utilities.

Photograph 36: West Access Pier Electrical Utilities
