Ilwaco Marina Conceptual Engineering Report

Client	Port of Ilwaco	
Project name	Port of Ilwaco Marina Repairs Concept Design	
Document title	Ilwaco Marina Conceptual Engineering Design Report	
Document subtitle –		
Status	Final	
Date	June 7, 2021	
Project number	11172	
File reference	Final Ilwaco Concept_Engr_Rpt

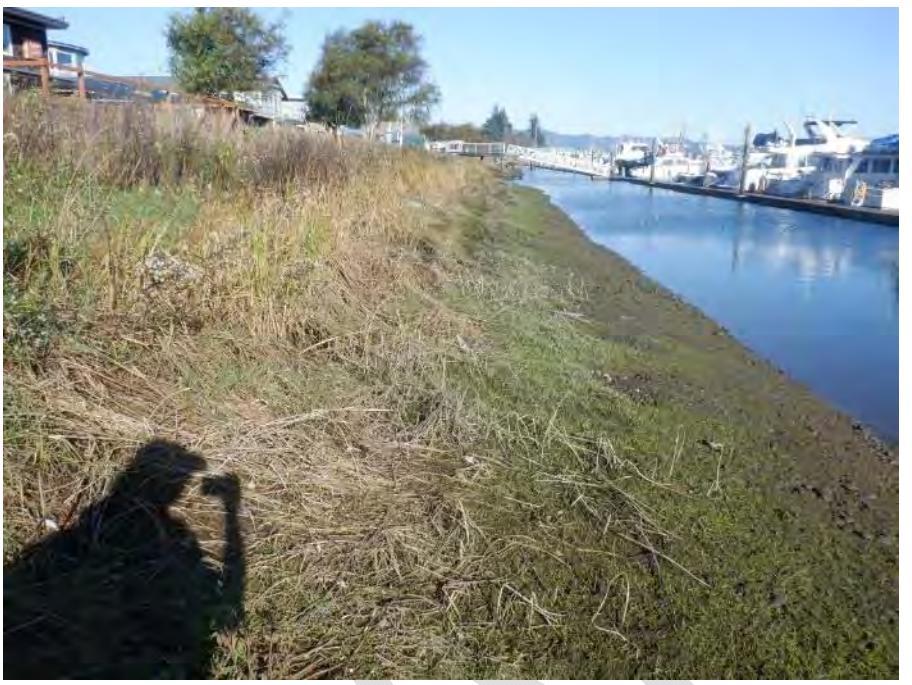
The shoreline east and west of the West Access Pier consists of vegetated slopes and small timber debris. No evidence of advanced erosion or sloughing is present. Photograph 38 and Photograph 39 show the typical condition of the shoreline.

Photograph 38: West Access Pier East Shoreline, Looking East
