Ilwaco Marina Conceptual Engineering Report

Client	Port of Ilwaco	
Project name	Port of Ilwaco Marina Repairs Concept Design	
Document title	Ilwaco Marina Conceptual Engineering Design Report	
Document subtitle –		
Status	Final	
Date	June 7, 2021	
Project number	11172	
File reference	Final Ilwaco Concept_Engr_Rpt

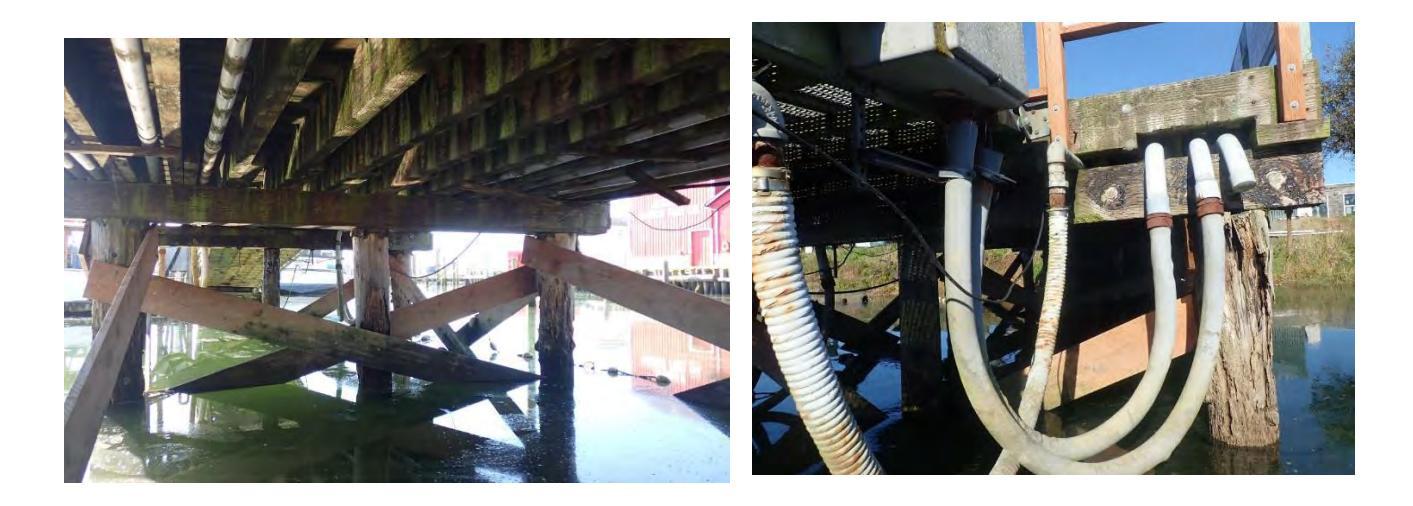
FIGURE 2.8: WEST ACCESS PIER UNDER DECK AND UTILITIES

Based on the results of the site visit and the evaluation performed in Task 2.1, the West Gangway Access Pier will be repaired or replaced. Observations of water levels at the site during high tides and/or storm events revealed the vulnerability of the pier deck and utilities to those high-water levels.

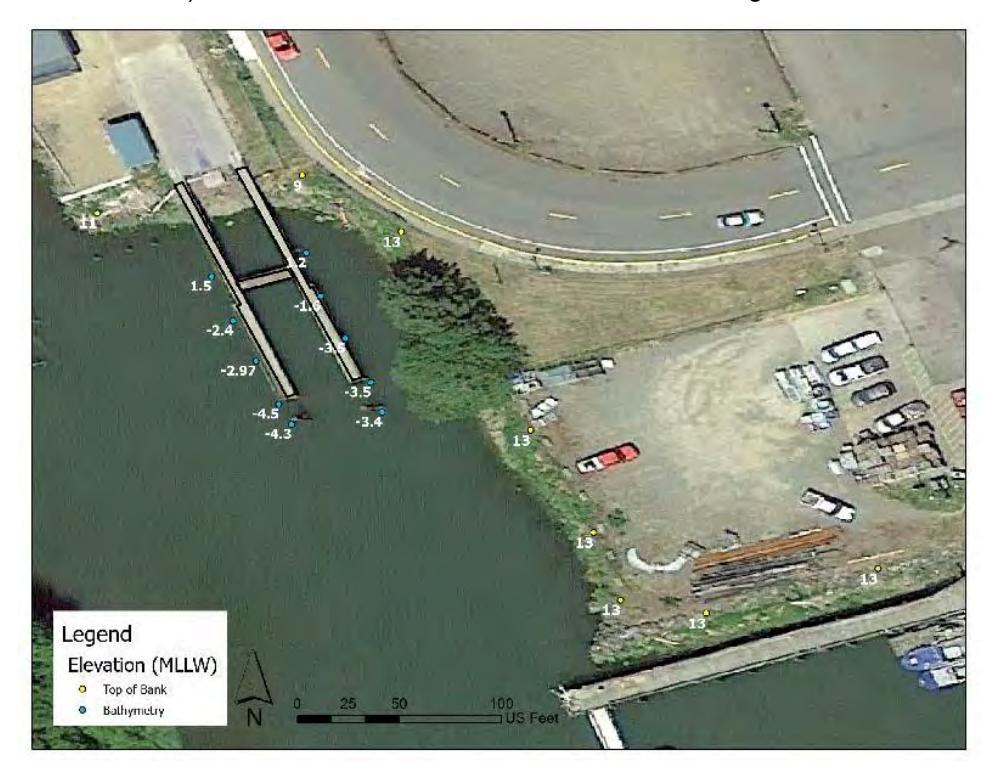
FIGURE 3.1: TRAVELIFT PIER CURRENT MUDLINE ELEVATIONS

the bank is currently being undermined and the adjacent slope is failing. There is a possibility that the increased vessel capacity will require dredging to provide for deeper draft vessels and/or to restore the basin to design depth. (The basin for the TraveLift was originally dredged to -10 ft MLLW. The current elevation ranges from approximately -4 to -6 ft MLLW). This consideration is outside the scope of this report but should be considered in further planning.

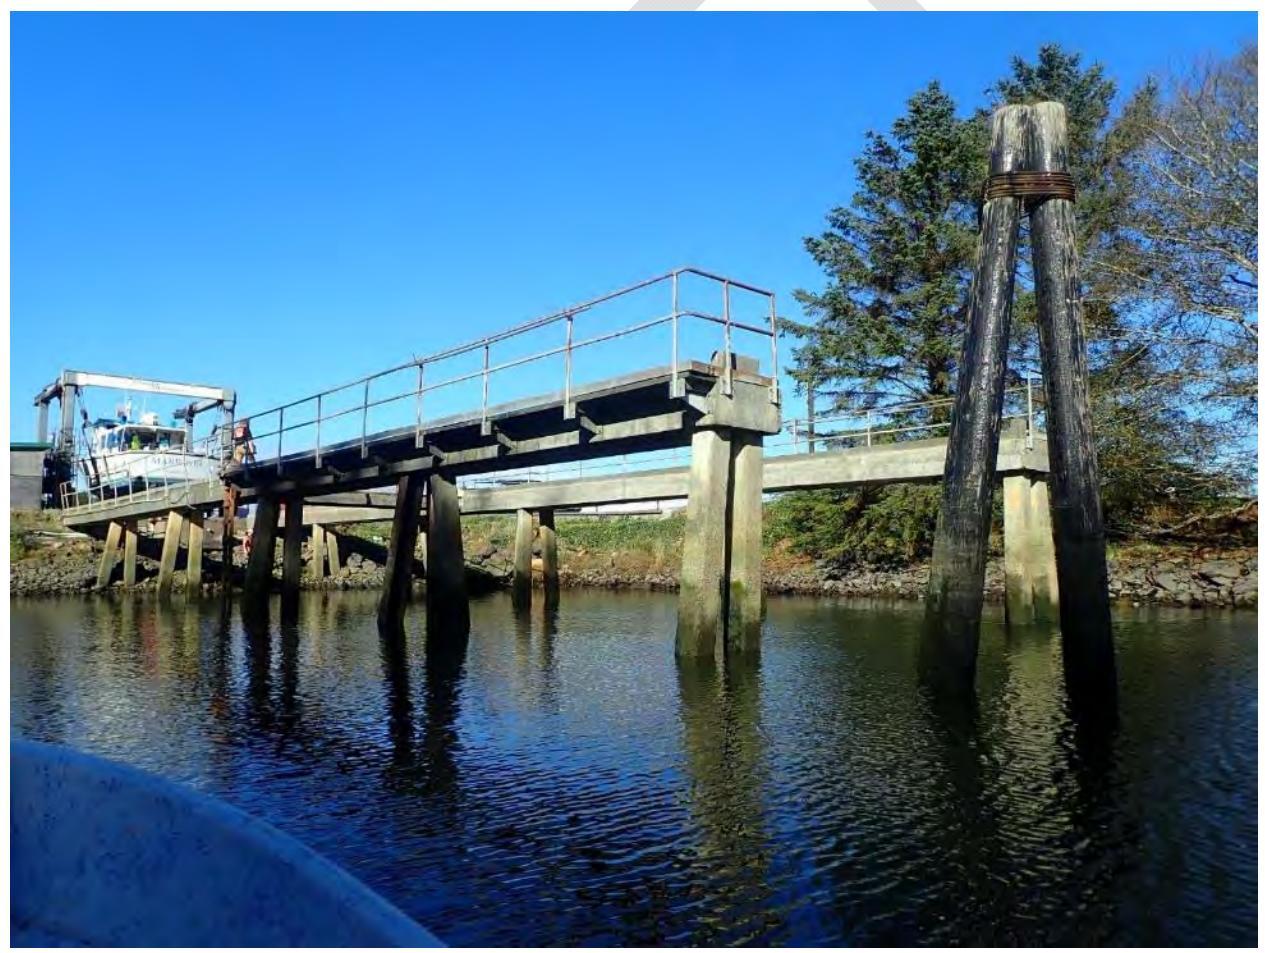
Photograph 1: TraveLift Pier

The TraveLift Pier consists of prestressed-concrete piles, a steel H-pile, reinforced concrete runway beams, a reinforced-concrete abutment, and steel handrails along the outer perimeter of the runway beams. A timber catwalk is located at approximately mid-length of the runway beams and consists of timber stringers, and decking. Timber-pile dolphins are located at the southern end of each runway. The adjacent shoreline consists of various sized rock armouring. The general arrangement of the TraveLift Pier is shown in Photograph 1.

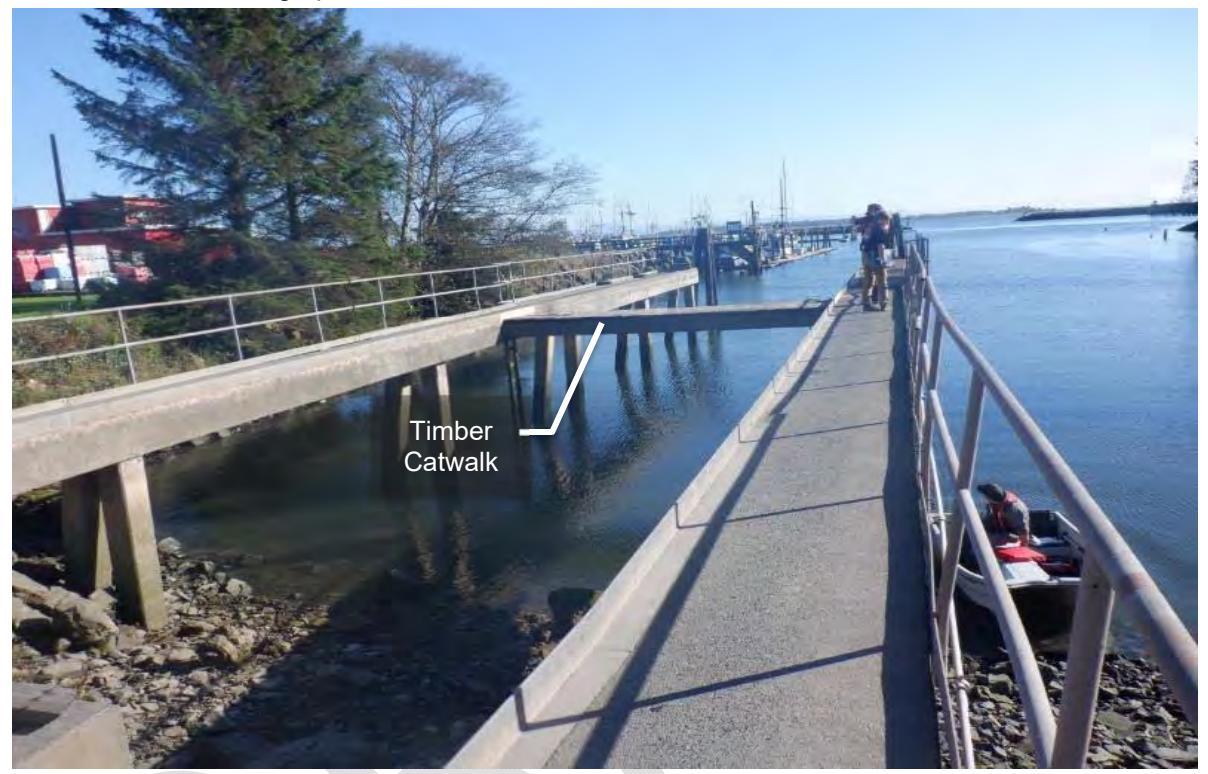
Photograph 7: Runway Beams from Atop Bent 1:A

The runway beams span across the top of the piles functioning as a both a pile cap and a travel path for each side of the lift during operation. The beams measure 20-inches deep and 42-inches wide consisting of reinforced concrete. The upper inside corner of the beams has a steel angle iron wheel guide/kick plate. The beams also support steel handrails, a timber catwalk spanning between the beams and a timber walkway cantilevered off the outside of the beams near the southern ends. A topside view of the runway beams is shown in Photograph 7.

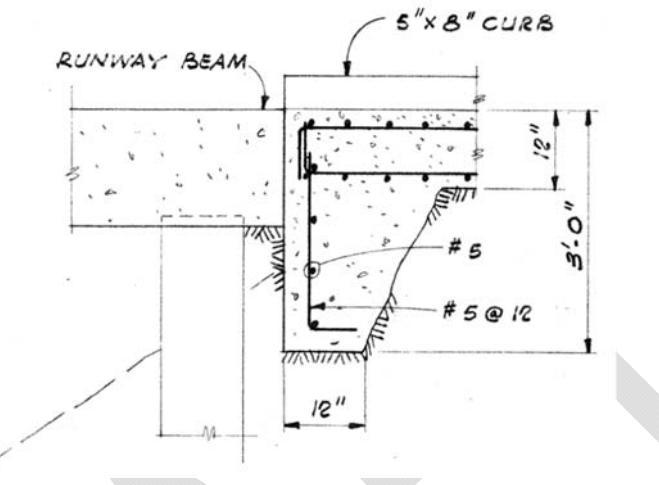
Figure 2: TraveLift Pier Abutment

A reinforced concrete abutment is located immediately north of the runway beams at the landside connection. A typical section of the abutment from the available as-built drawings is shown in Figure 2 below. In general, no damage or deterioration was observed on the concrete elements of the abutment, however, the concrete abutment shows signs of localized settlement. The top of the concrete abutment is approximately two-inches lower than the top of the adjacent runway beam surface. Wood wedges with a steel covering have been placed at the transition to compensate for the height difference.

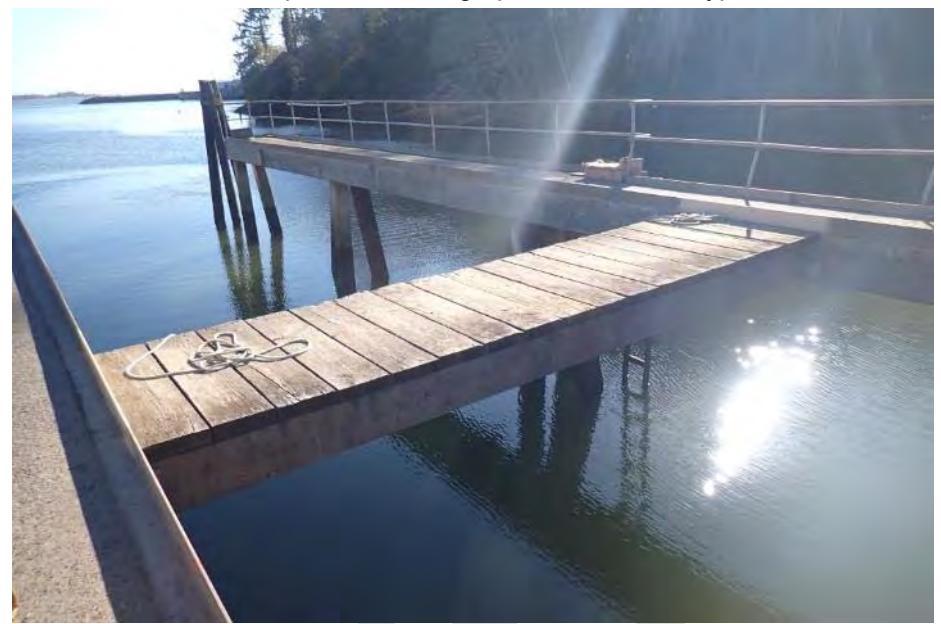
Photograph 11: Timber Catwalk

A timber catwalk, oriented perpendicular to the runway beams, is located at approximately mid-length of the runways. The catwalk consists of pressure treated timber stringers and timber decking. The stringers are connected to the runway beams with steel brackets and anchor bolts. The minor checking and weathering of the timber elements is present. Photograph 11 shows the typical condition of the catwalk.

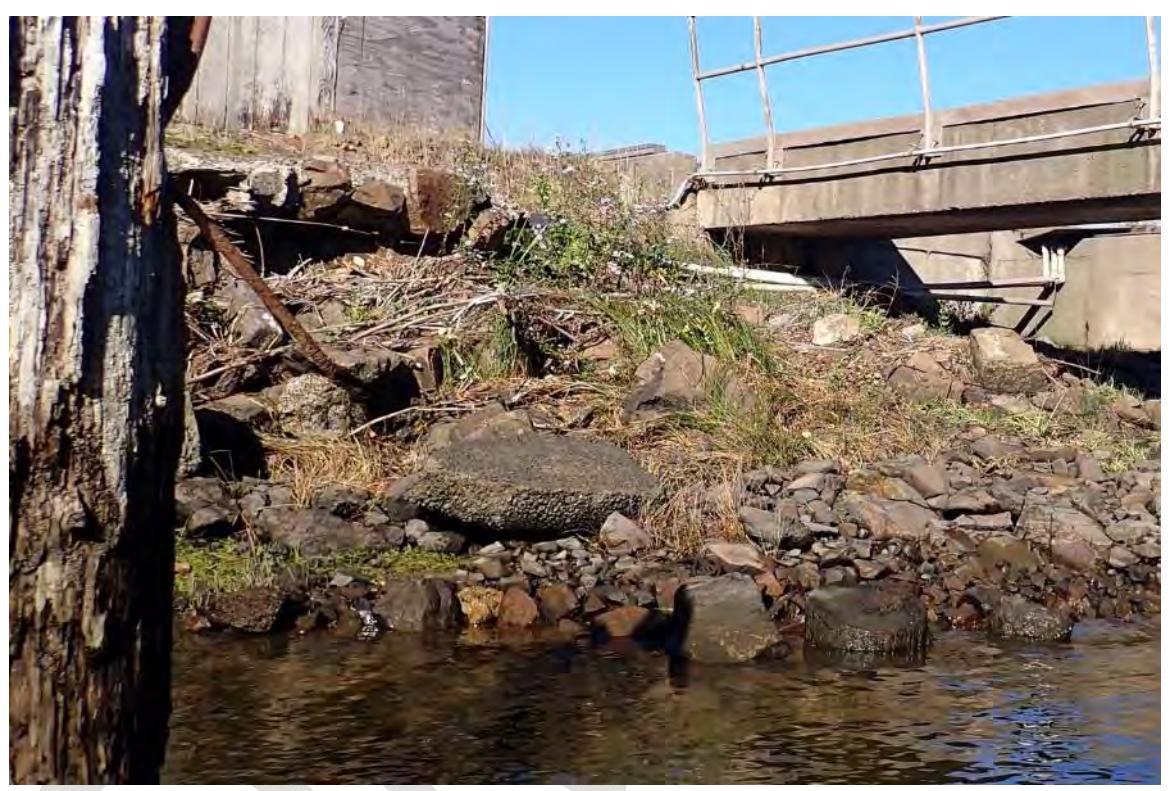
Photograph 13: Shoreline West of TraveLift Pier

The shoreline immediately adjacent to the TraveLift Pier consists of mix-sized riprap and sparse vegetation. Evidence of erosion of the slope is present, most notable beneath the concrete vault located between the runway beam. Loss of material is estimated to be approximately one-foot thick, over an area of 1,000 square feet. The inconsistency of riprap size along the shoreline suggests that material has moved or been displaced since the original construction. This is further evident with the difference in elevation between the abutment and the runway beams, discussed previously. Photograph 13 and Photograph 14 show the typical condition of the shoreline. Photograph 15 shows the erosion below the concrete vault.

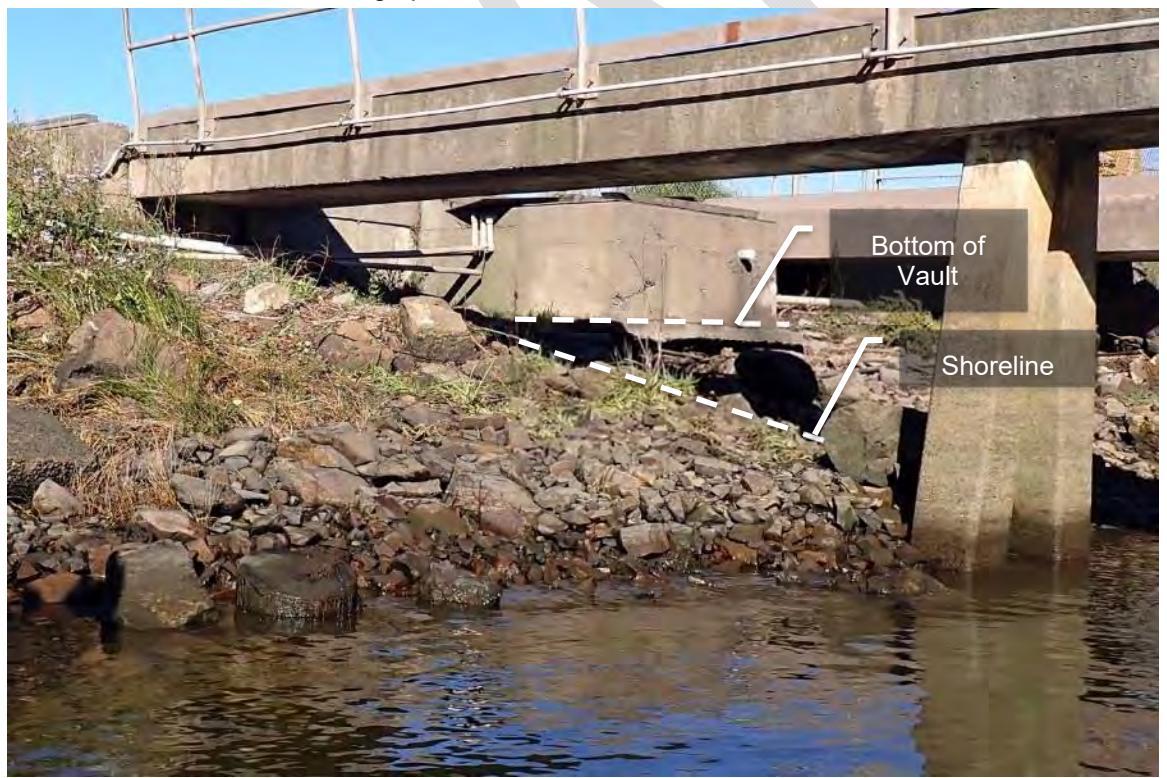
Photograph 15: Erosion Evident Below Concrete Vault

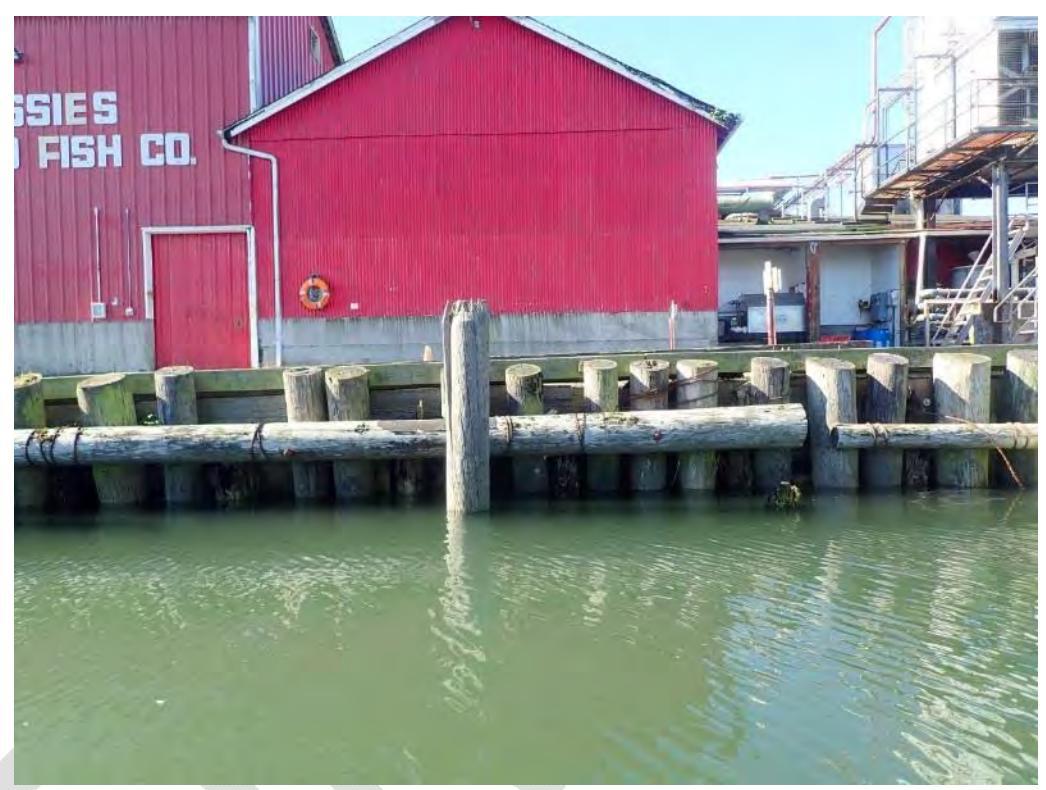
Photograph 16: Jessie's Wharf East Bulkhead

The East Bulkhead consists of creosote treated timber piles, lagging and walers. Wire strand tiebacks connected to the timber waler are presumed to connect to buried deadman in the upland area. Three steel pipe piles are located along the face of the bulkhead and are assumed to be used for mooring of vessels. The adjacent northern shoreline consists of a vegetated slope and a timber pile bulkhead retaining structure. The shoreline south of the East Bulkhead consists of various sized rocks and concrete debris. Timber pile stubs are located south of the southern shoreline. The general arrangement of the East Bulkhead is shown in Photograph 16.

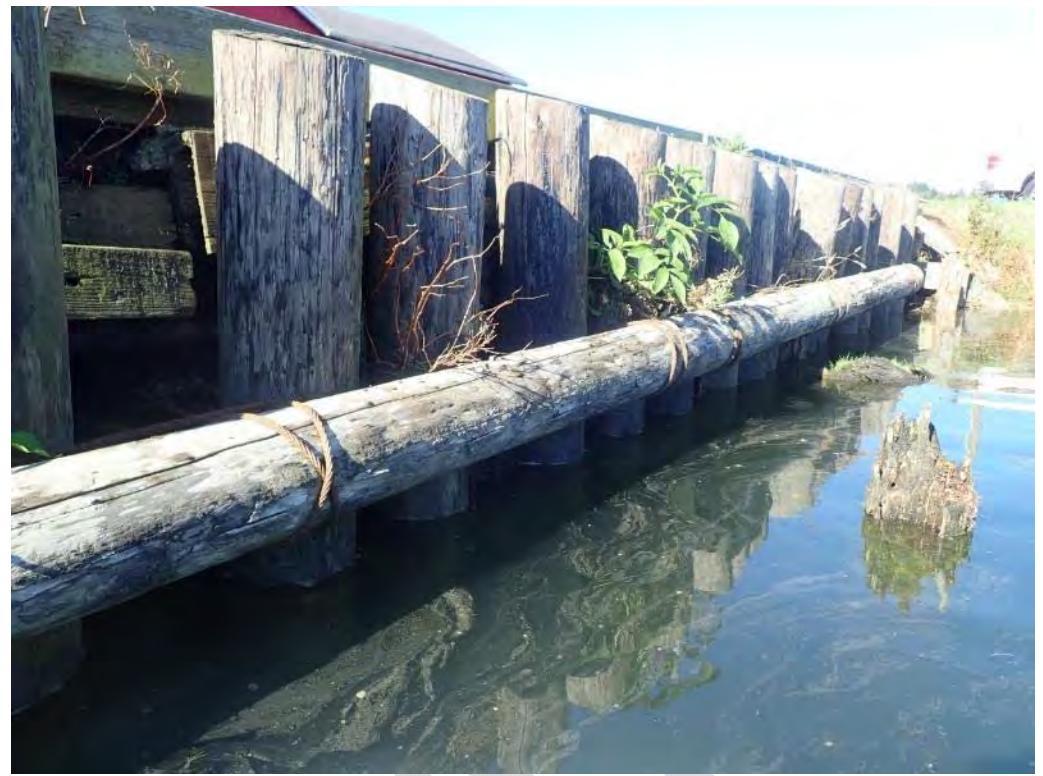
Photograph 20: East Bulkhead Waler

Minor damage, including checking and splitting is present throughout the lagging and waler members. Additionally, moderate to severe deterioration of the lagging, including section loss, and breakage is present. The deterioration has led to gaps between adjacent lagging members, measuring up to several inches wide and allows for loss of backfill material. This loss of material has led to subsidence of the upland area. The East Bulkhead lagging, walers, and tieback strands are shown in Photograph 19 through Photograph 21.

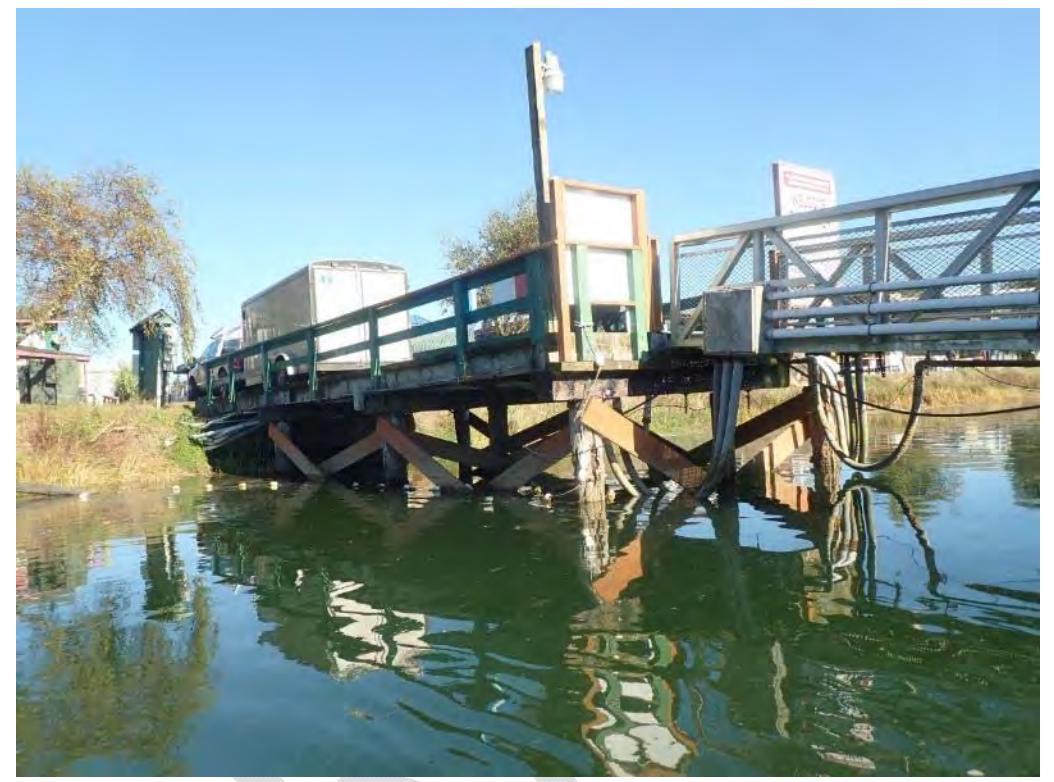
The West Access Pier consists of treated timber components including piles, pile caps, stringers, cross bracing, and decking. A concrete abutment connects the pier to the upland area. Water and electrical utilities which service the marina are supported along the pier and transition onto an aluminium gangway. The adjacent shoreline consists of a vegetated slope. Photograph 26 shows an elevation view of the West Access Pier.

Photograph 26: West Access Pier, Looking Northeast (Water Level Approx. +6.3-feet MLLW)

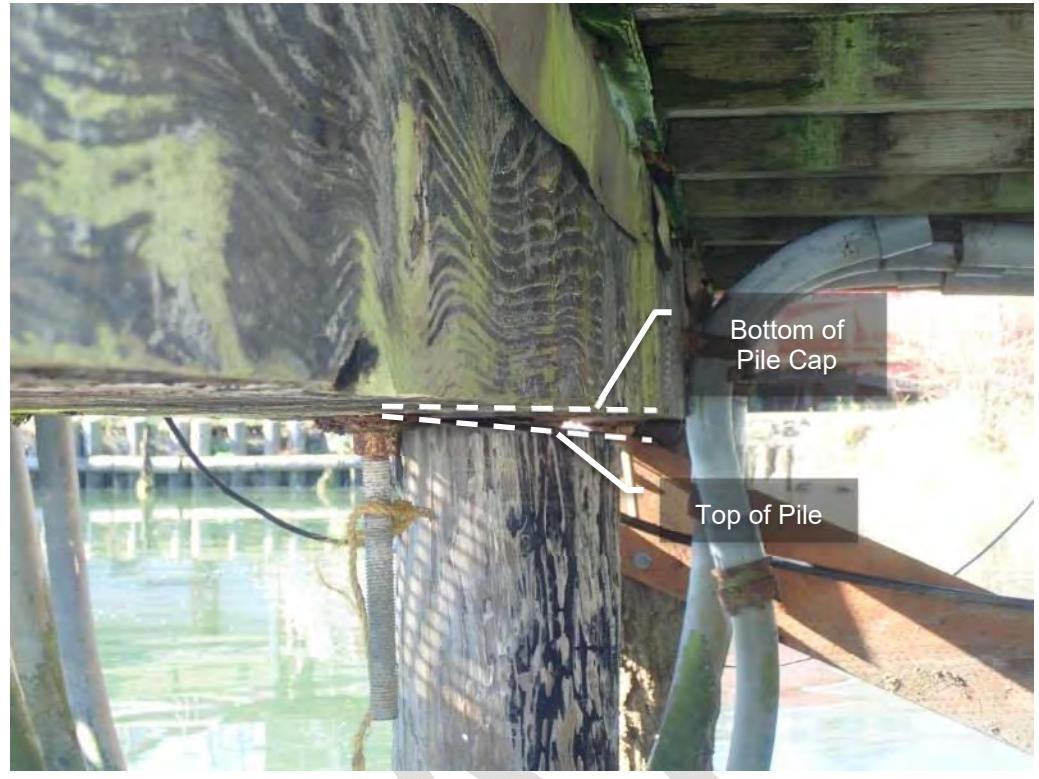
Major damage including diameter loss greater than 15-percent as a result of delamination of the outer shell and piles partially supporting the pile cap was observed on eight of the nine timber piles (89-percent). Photograph 27 shows diameter loss of Pile 3:A. Photograph 28 shows Pile 4:B partially supporting the pile cap.

Photograph 28: West Access Pier Timber Pile 4:B, Partially Non-Bearing

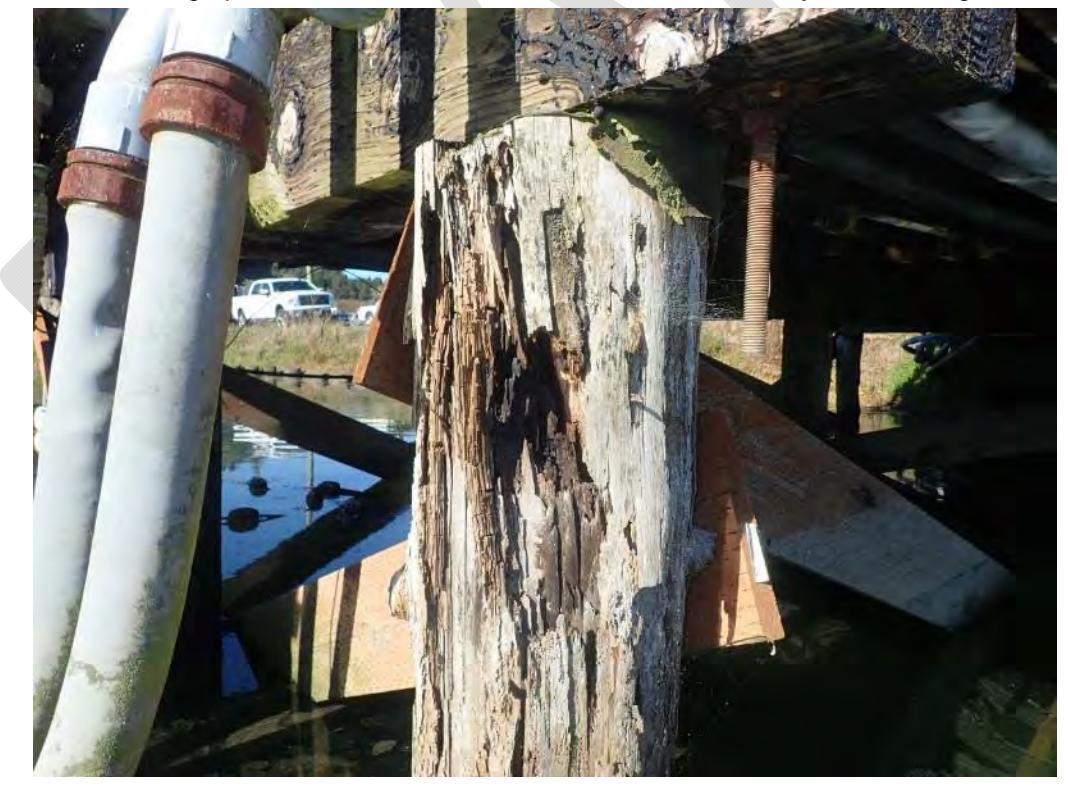
Severe damage was observed on one of the nine timber piles (11-percent). Photograph 29 shows Pile 4:C with severe cross-section area loss.

Photograph 29: West Access Pier Timber Pile 4:C with Severe Section Loss

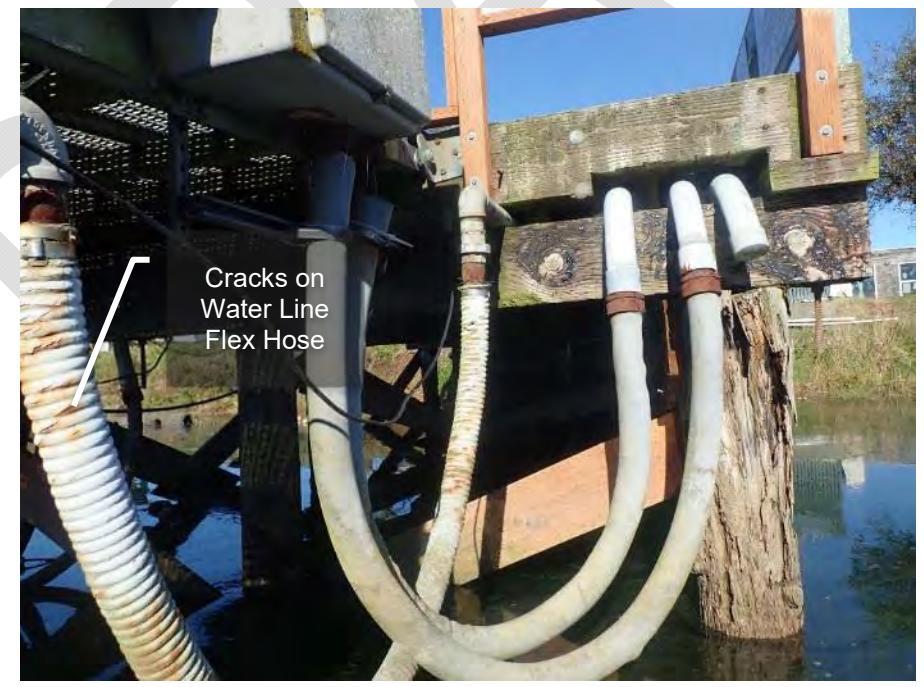
Utility conduit and piping for electrical and water systems are hung from the West Access Pier and transition onto an aluminium gangway. The electrical flex connection on the east side of the gangway has separated from the junction box and the water line flex hose is cracked near the southeast corner of the pier. Photograph 36 and Photograph 37 show the typical condition of the utilities.

Photograph 37: West Access Pier Water Flex Hose

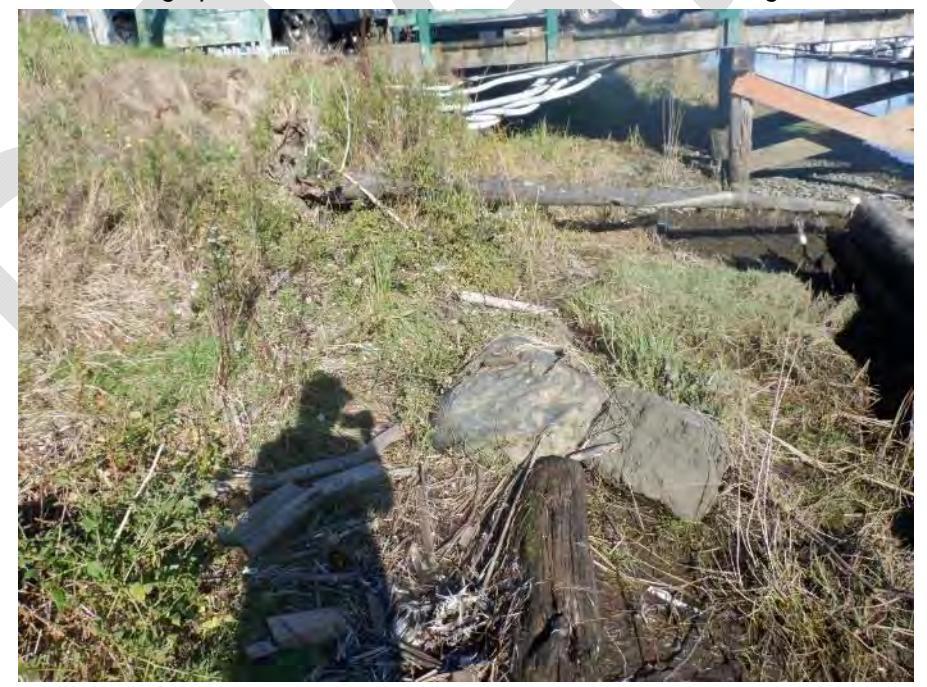
The shoreline east and west of the West Access Pier consists of vegetated slopes and small timber debris. No evidence of advanced erosion or sloughing is present. Photograph 38 and Photograph 39 show the typical condition of the shoreline.

Photograph 39: West Access Pier West Shoreline, Looking East
